Marine notice 07/2023

GUIDANCE FOR THE SAFE CARRIAGE OF BATTERY POWERED VEHICLES ON SHIPS

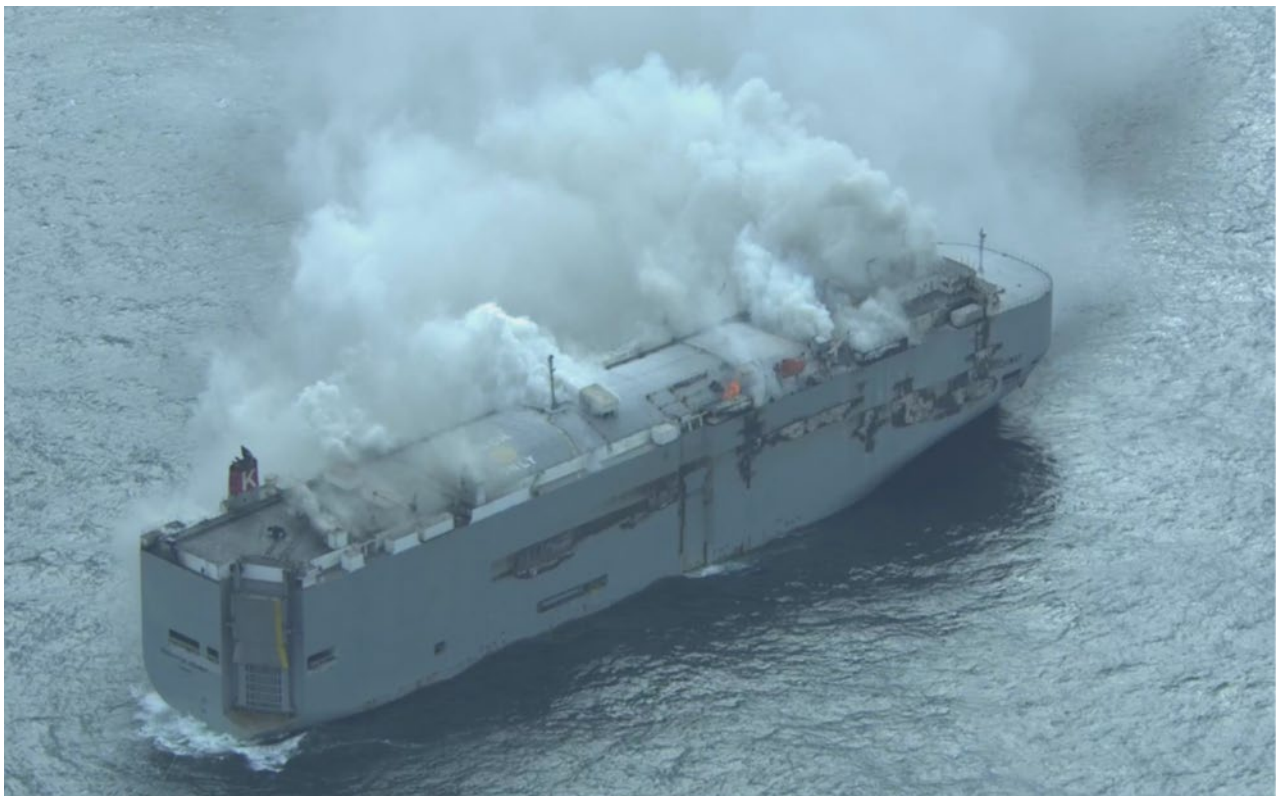
PCTC Fremantle Highway in July 2023. Photo courtesy of Brookes Bell.

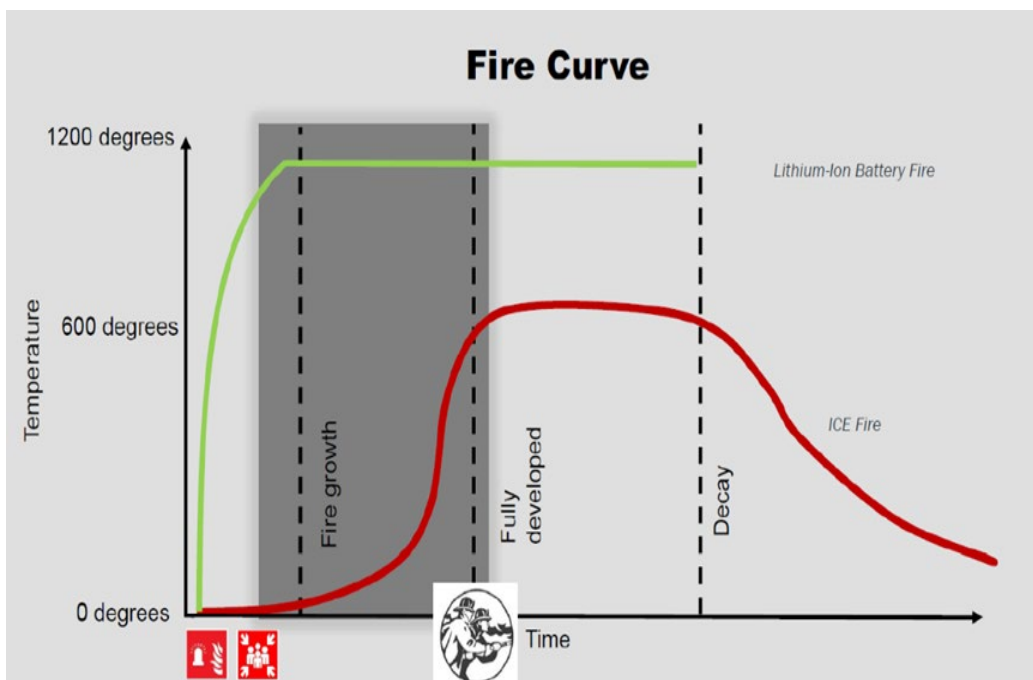
Figure 1: Time taken to reach maximum fire potential. Graph courtesy of Brookes Bell.

While the likelihood of fires for BEVs is very low compared to fires from internal combustion engines (ICE vehicles are 60 time more likely to catch fire), the fires involving BEVs reach full potential in a shorter period in comparison. Typically flames shoot upwards and outwards simultaneously. BEV fires can reach temperatures of more than 1600 degrees centigrade, hot enough to burn metals like aluminium, commonly used in BEV construction to reduce weight. See below diagram which compares the time taken by BEV fires.

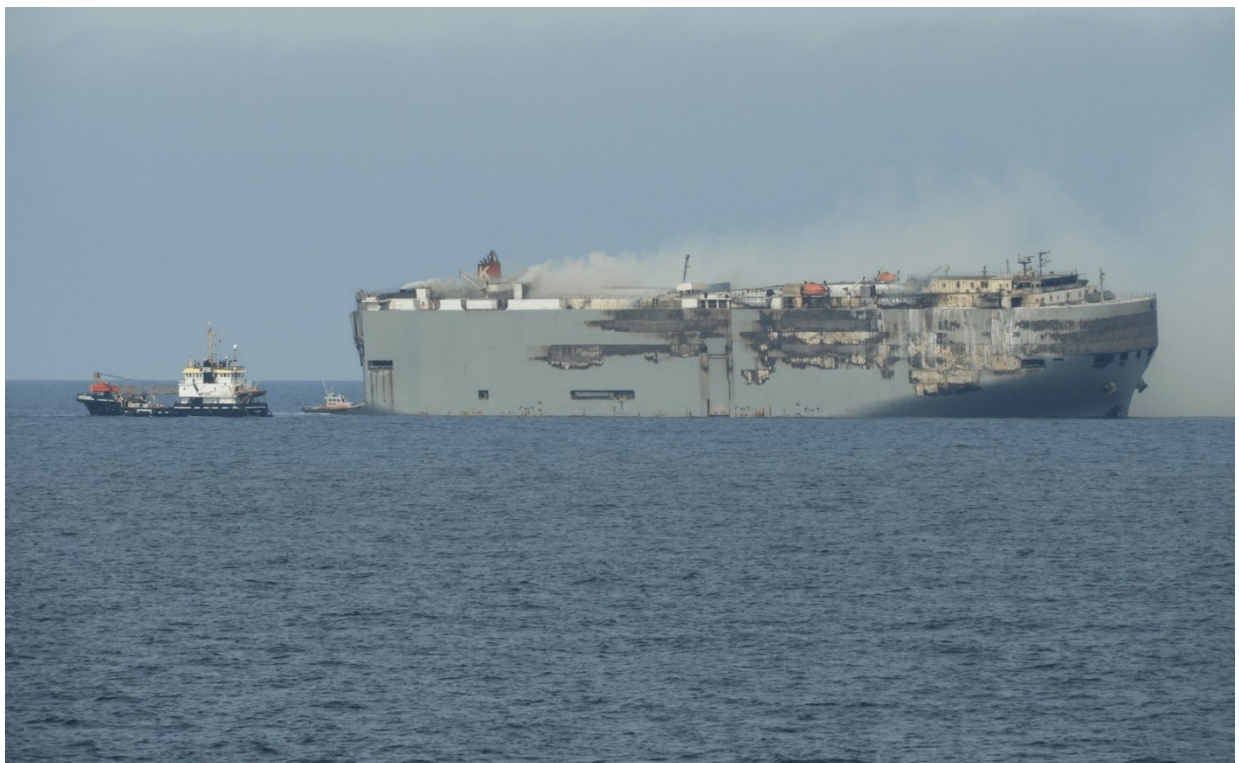
MV Fremantle Highway. Photo courtesy of Netherlands Coastguard.
