Attachment 1: North Reef Lighthouse General Condition

Attachment 1 shows a general overview of the types of defects found and subsequent repairs required. Note the photos were taken in 2007-08 and the amount of damage and deterioration will be greater.

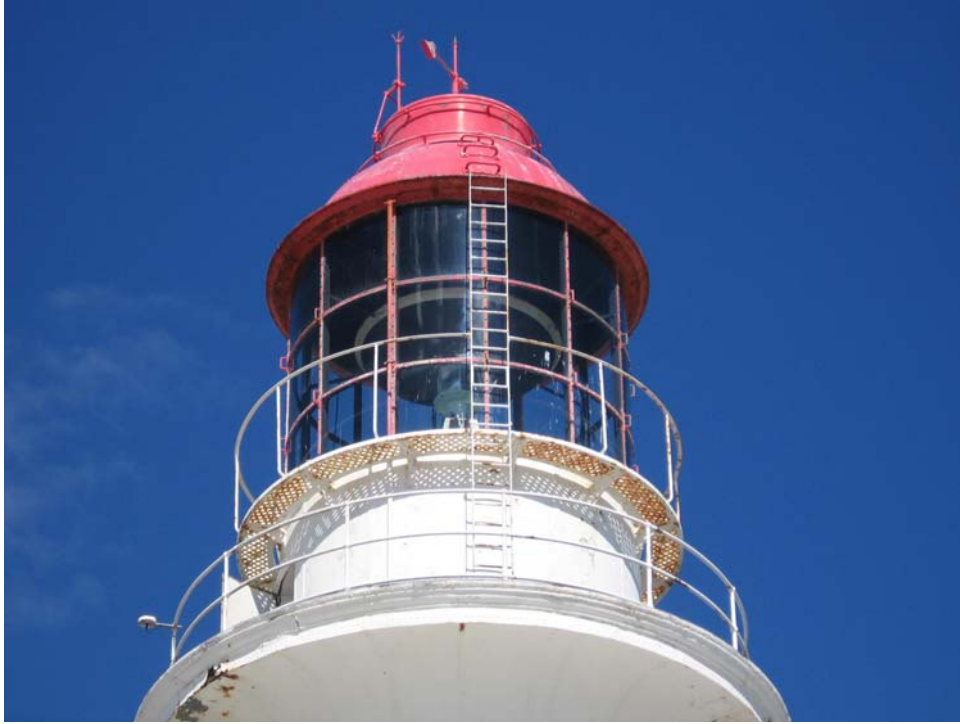
Lantern Room

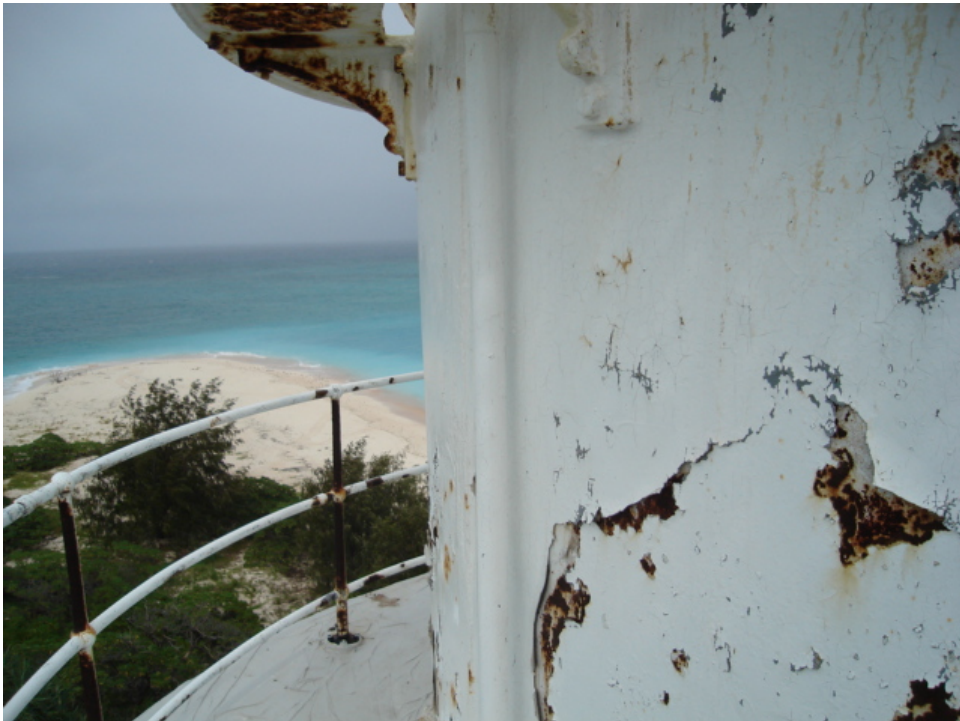
Lantern Room

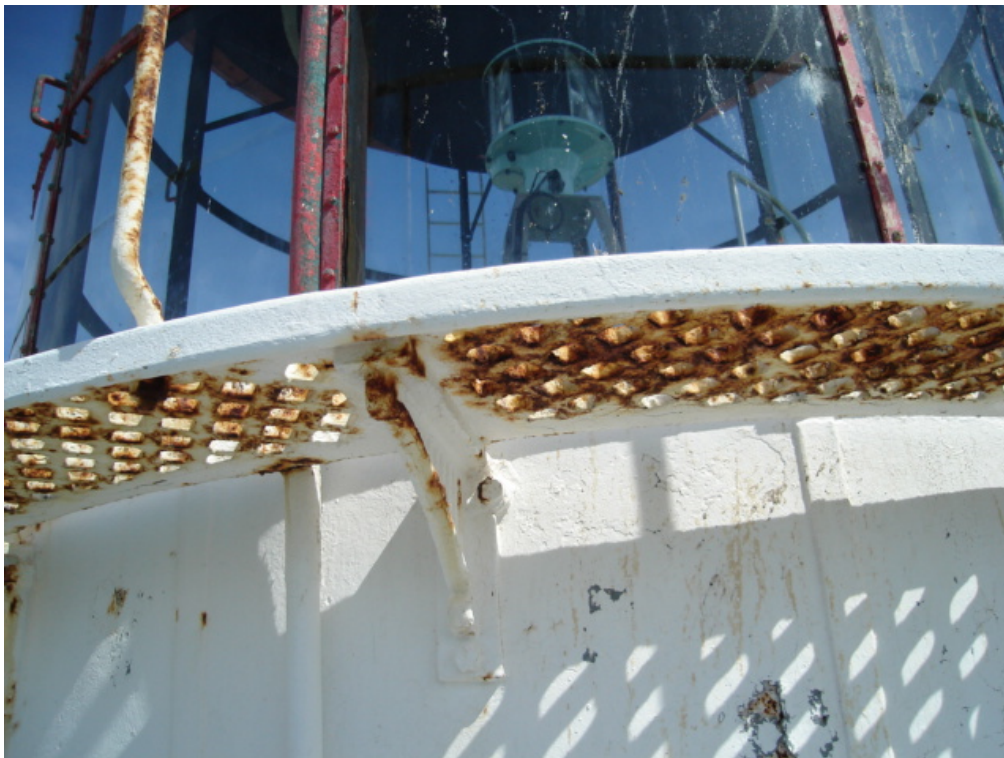
External corrosion and paint system

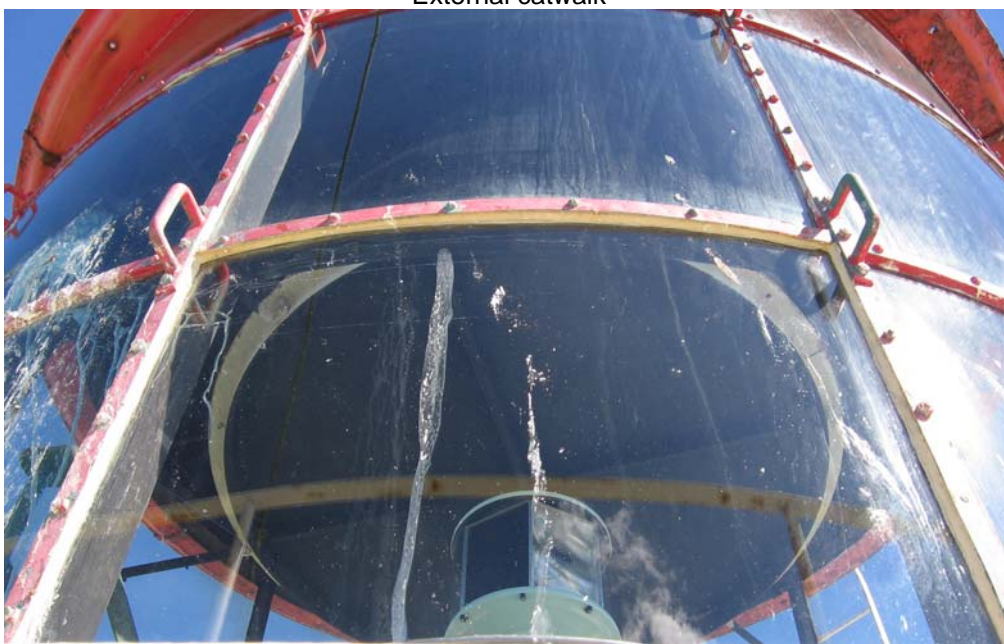
External catwalk

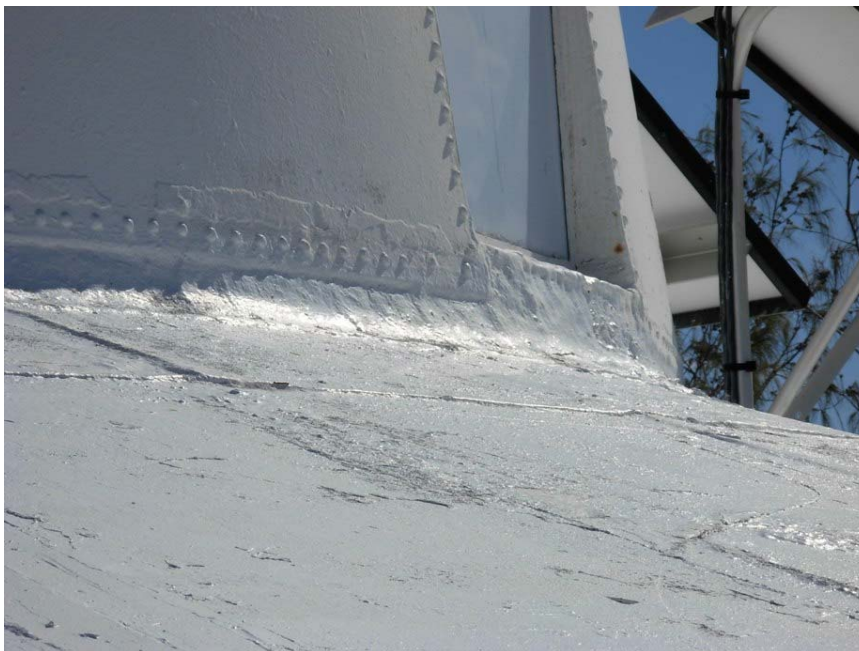
Sealing interface between tower and quarters roof

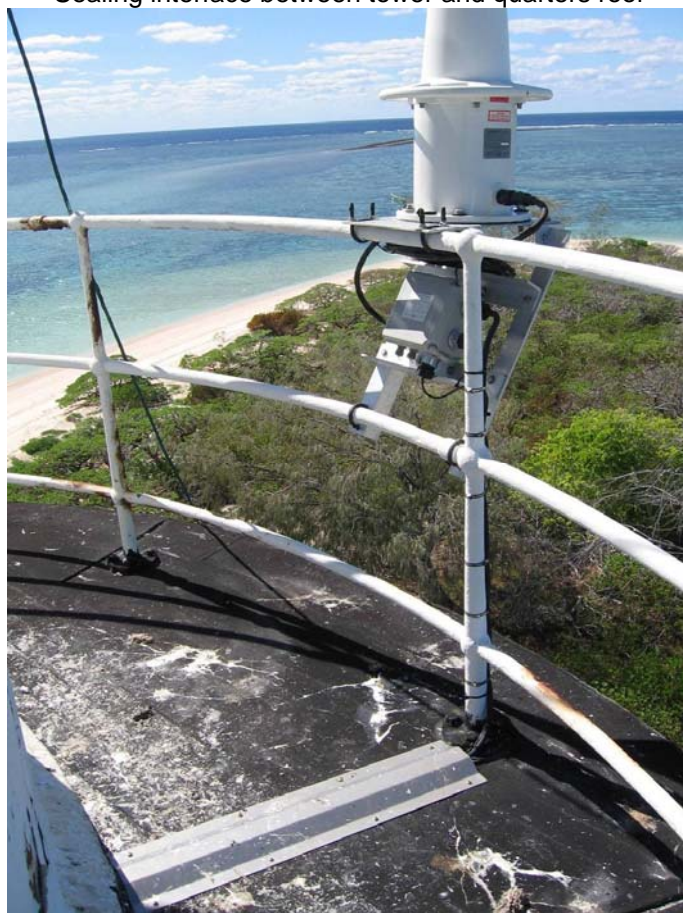
Balcony sealing interface between lantern room and soffit

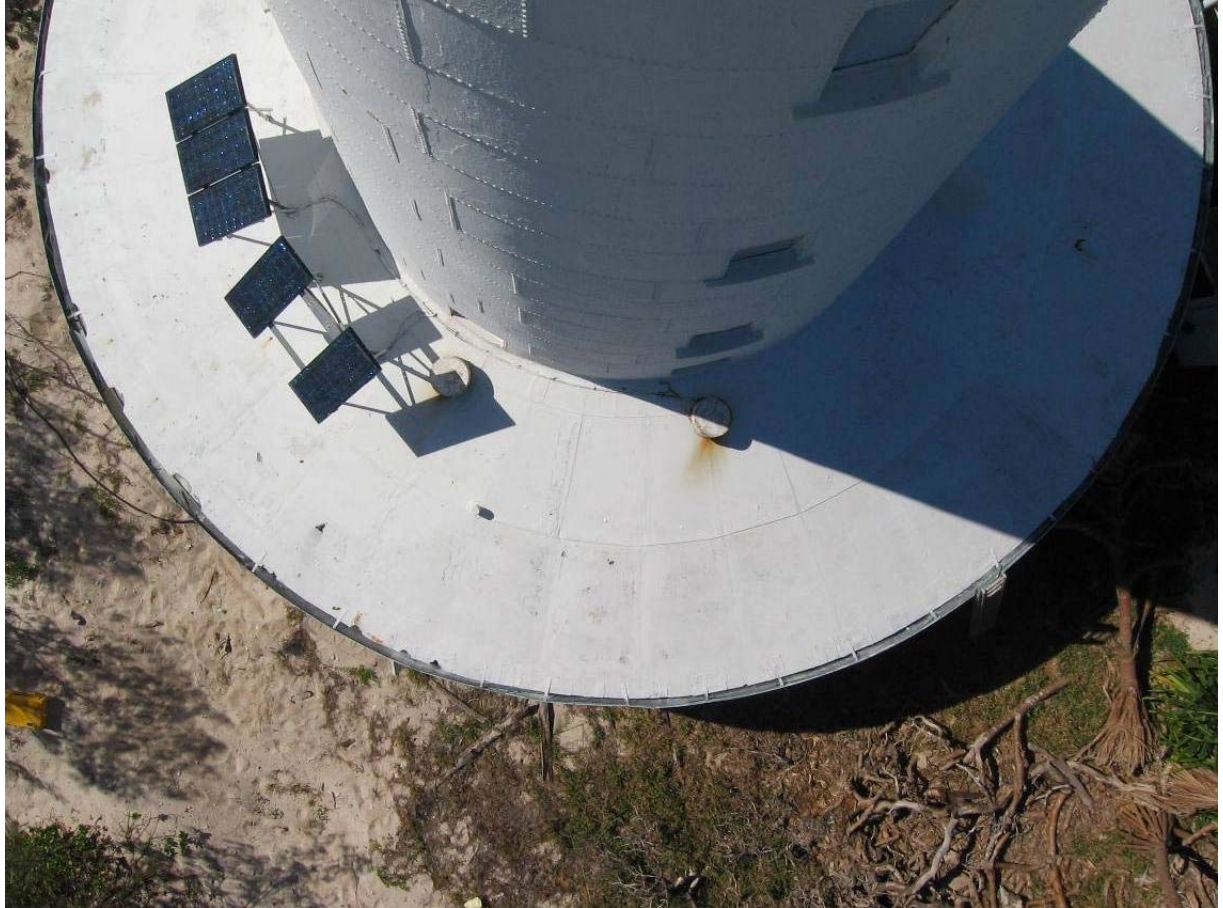
Flat sheet quarters roof

Re-roofing

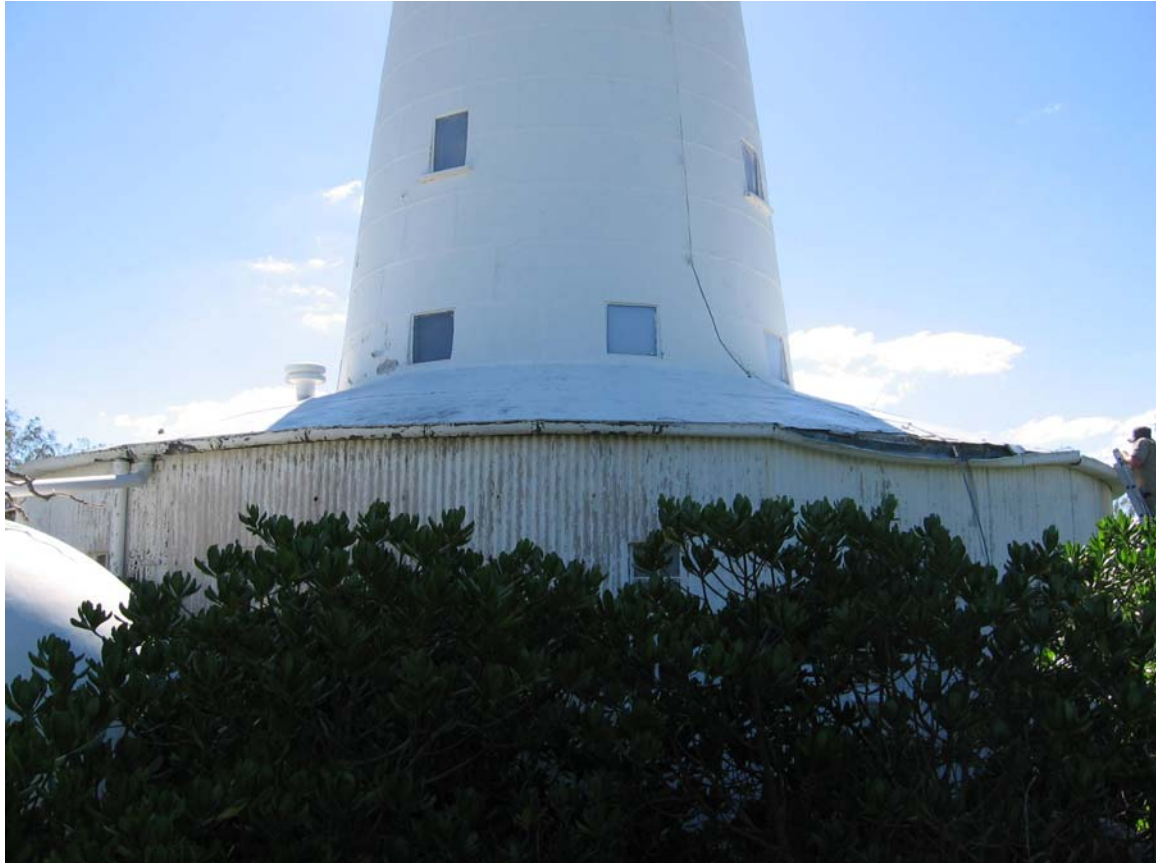
External asbestos corrugated cladding

Re-cladding

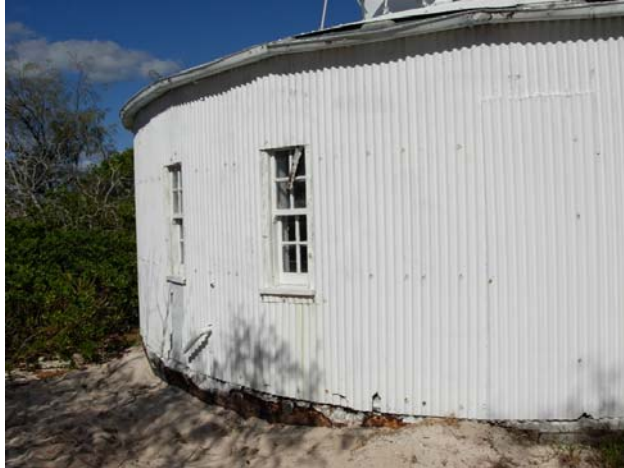
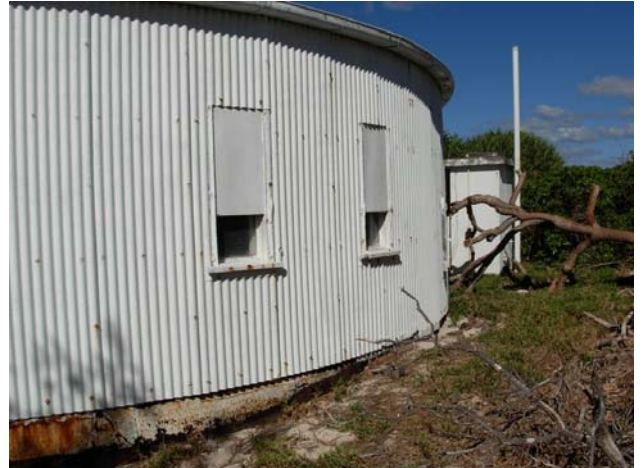
External windows

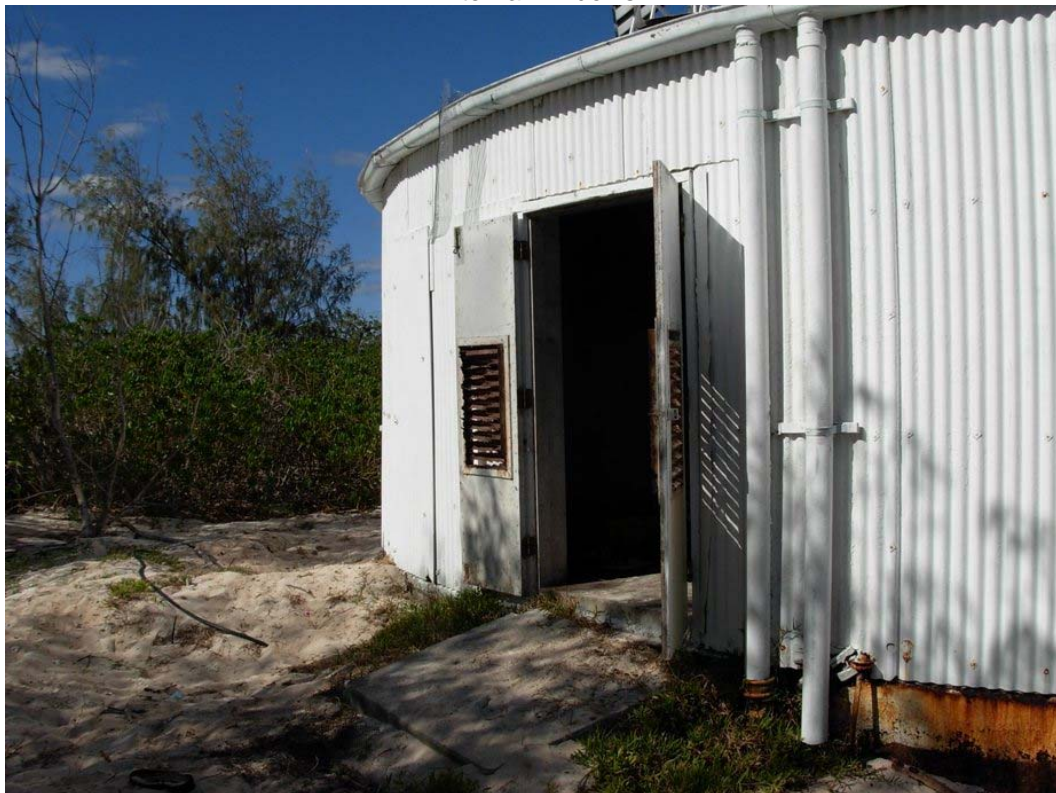
External doors

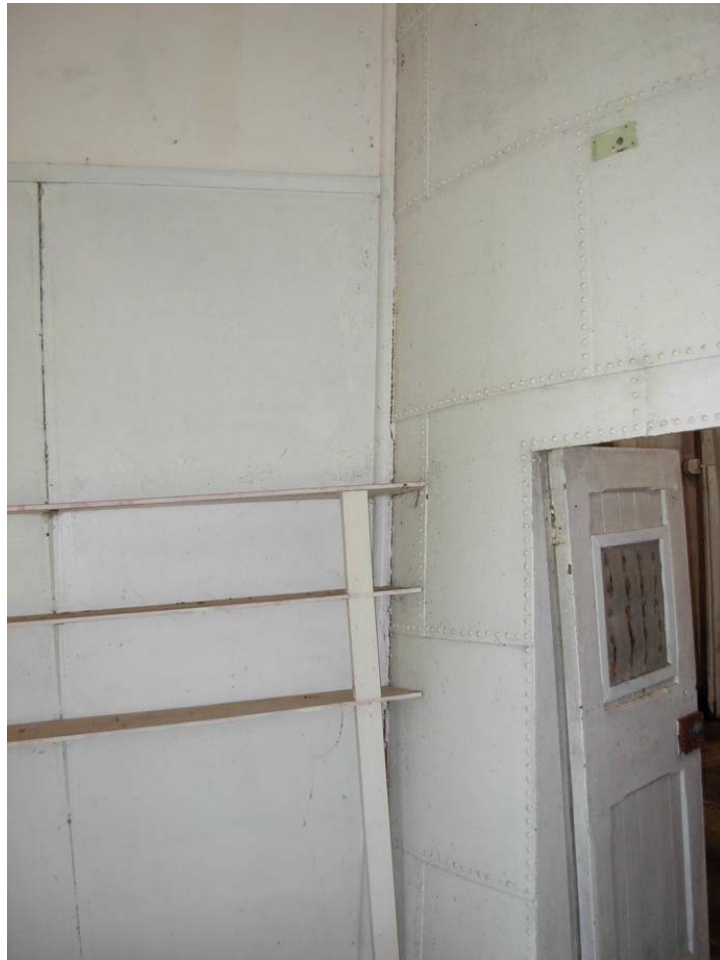
Quarter's room

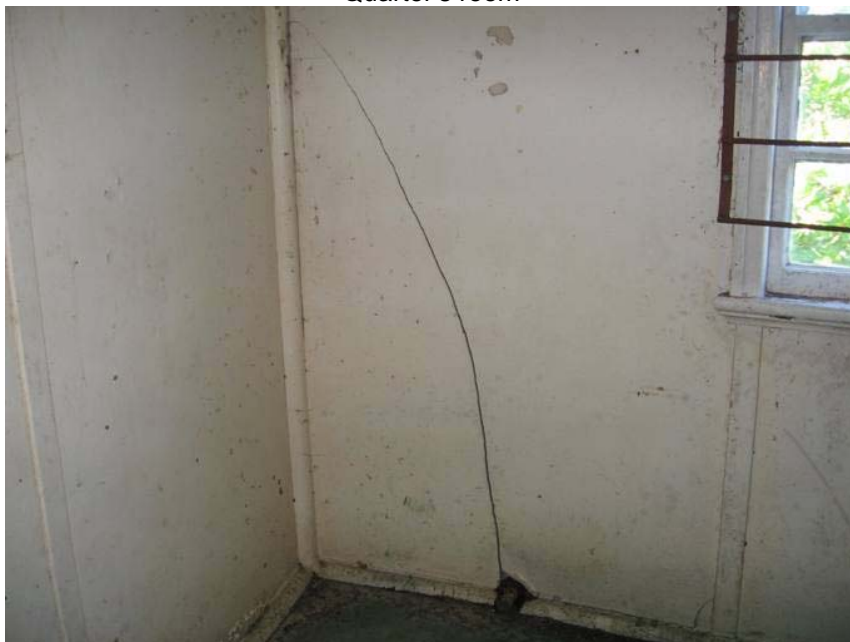
Quarters internal wall sheeting

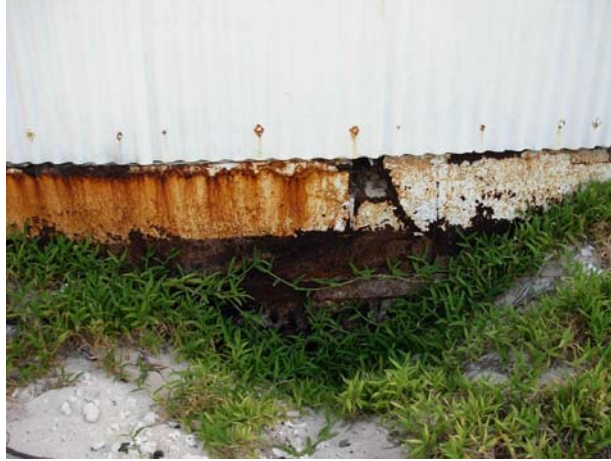
Erosion / corrosion around caisson / foundation

Foundation erosion / stabilisation

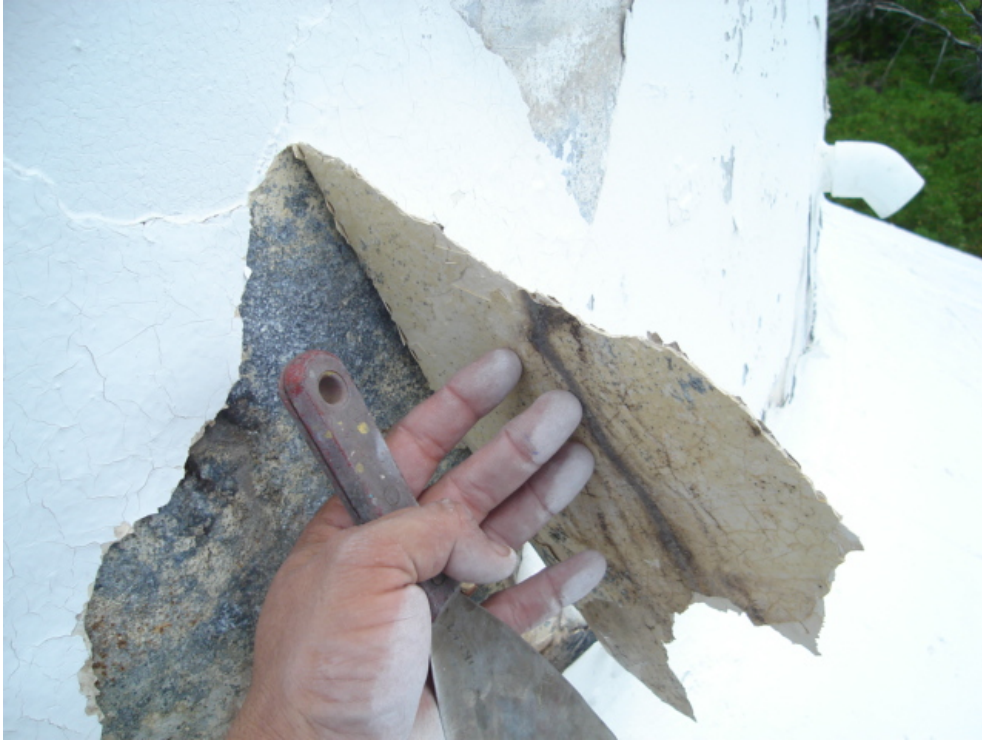
Condition of tower paint system – test showing adhesion

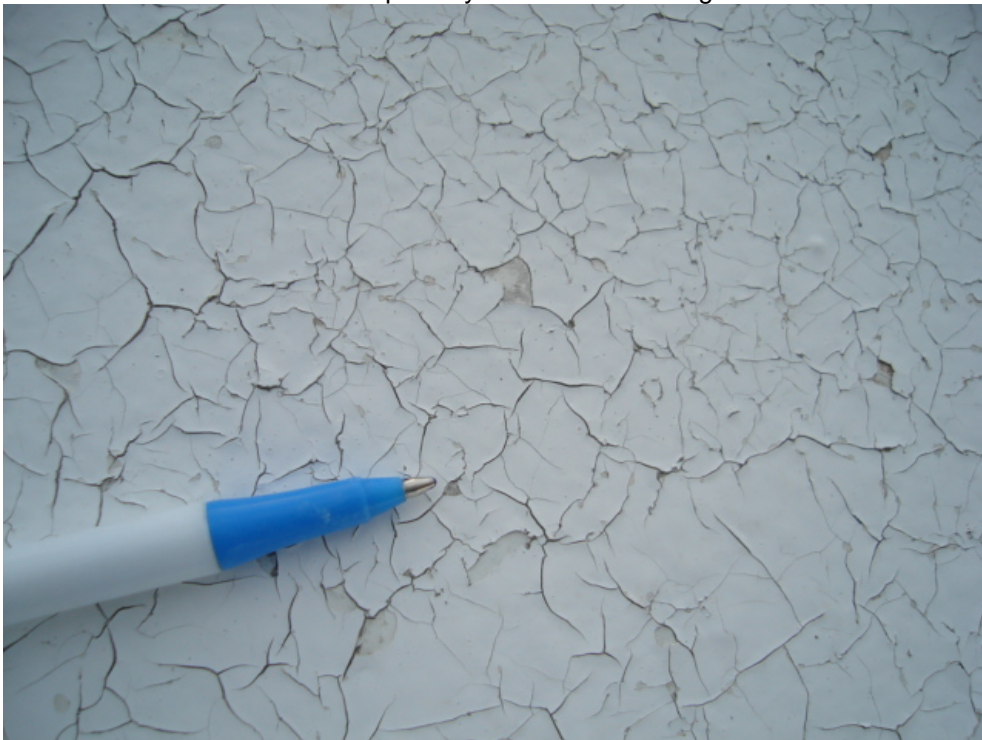
Condition of tower paint system

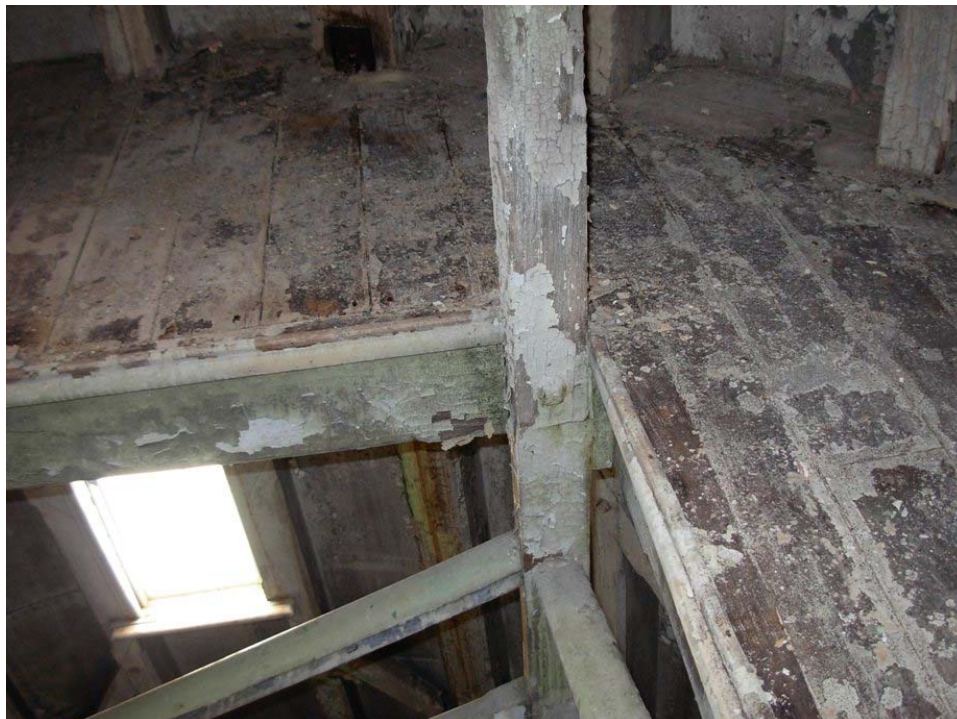
Condition of internal paint system

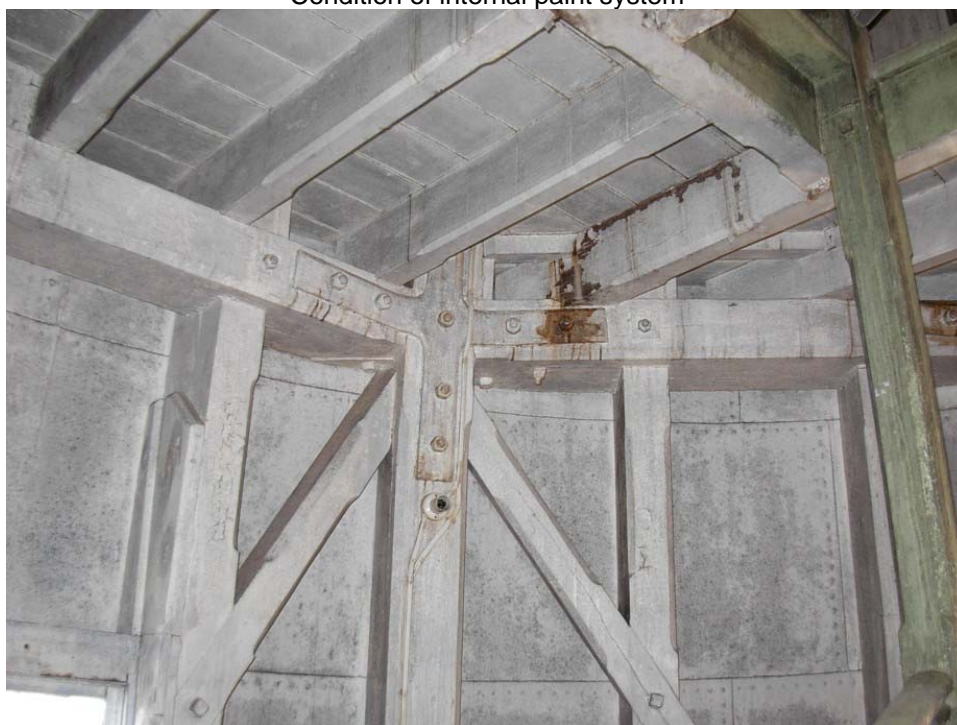
Condition of internal paint system

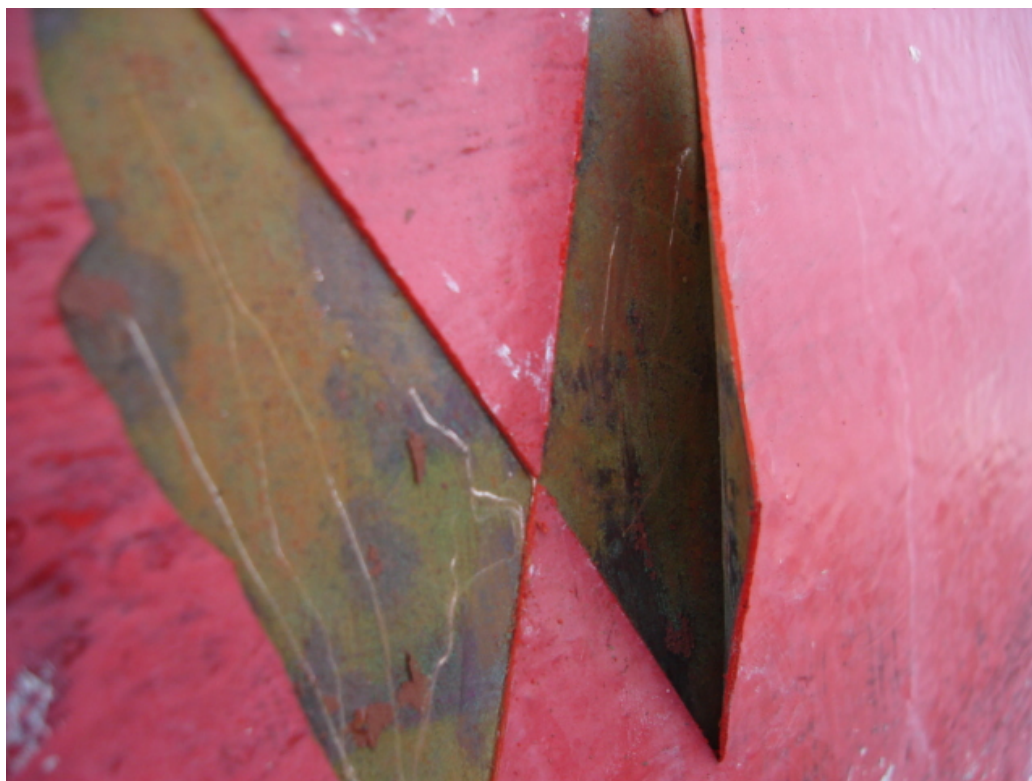
Condition of dome paint system – test showing adhesion
