Marine Notice 15/2015

## Free-fall lifeboat safety

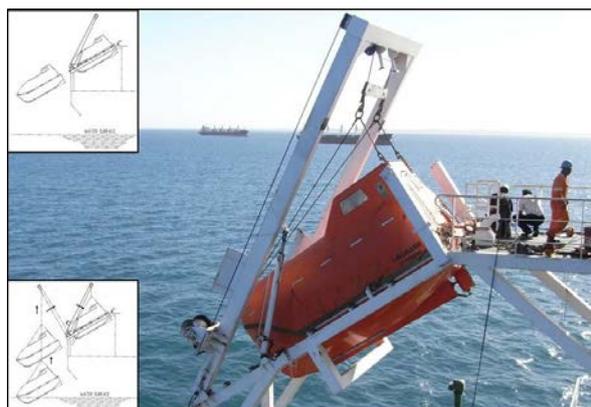
Aquarosa (IMO No. 9506708) - On 1 March 2014, Aquarosa's free-fall lifeboat was inadvertently released during a routine maintenance inspection while the ship was en route to Fremantle, Western Australia. One crew member was injured in the incident and it took 5 hours for the crew to recover the lifeboat.

*Aquarosa's Free-fall Lifeboat arrangement*

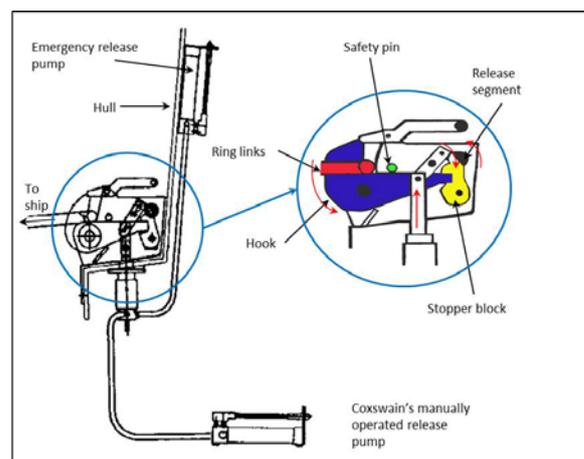
The ATSB identified that the Second Engineer accidentally activated the lifeboat's on-load release mechanism while carrying out a test procedure. When the Second Engineer cycled the hydraulic system, the retaining hook was released allowing the lifeboat to move down the launch ramp.

The ATSB found that the hydrostatic on-load release mechanism hydraulic cylinder ram had not fully retracted after use, preventing the stopper block from resetting correctly. This left the release hook in a partially disengaged position.

The ATSB noted that the design of the release mechanism cover plate prevented visual confirmation that the hook was correctly reset.

*Aquarosa's free-fall lifeboat release system*

The lifeboat was fitted with simulation wires to prevent it from launching under these circumstances. However, on this occasion, the simulation wires failed allowing the lifeboat to move down the guide rails into the sea. The ATSB found that the simulation wires failed due to a combination of incorrect installation and cumulative internal wear from numerous shock loading events that resulted from previous lifeboat launching drills.

- Ships' crews following established maintenance procedures and being vigilant and observant during all maintenance tasks.
- The examination of maintenance procedures to ensure they are effective.
- Effective crew familiarization and training, to minimise risk when crew are conducting test procedures and training drills.

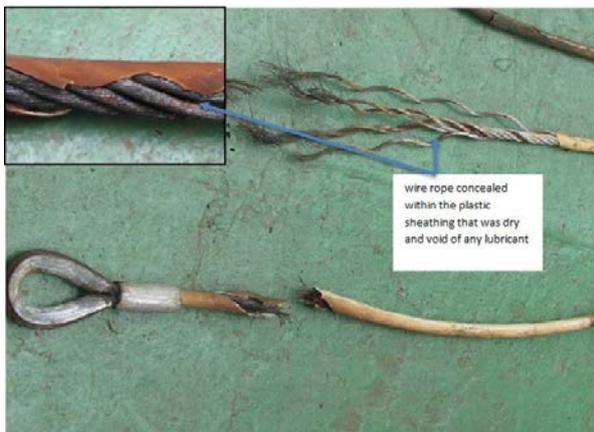
TAIC identified that the wire pennants parted under tensile overload. Subsequent testing confirmed that the sling wires had been significantly weakened by severe corrosion. This corrosion had gone undetected inside a plastic sheathing that the manufacturer had fitted to the wire.

The sheathing prevented the crew from identifying the corrosion and did not allow for lubrication or the application of other corrosion-inhibiting substances. The crew were also unaware of the necessity for greater vigilance and the application of anticorrosive substances during inspections.

Examples of the damage to *Da Dan Xia*'s wire slings after failure (Courtesy TAIC)

TAIC found that the wires were of adequate strength when manufactured, but that the sheathing allowed saltwater ingress, aiding corrosion by retaining water, and prevented external observation.
