Australian Maritime Safety Authority

Fact finding report into the reported collision involving

Ady Gil

Shonan Maru No. 2

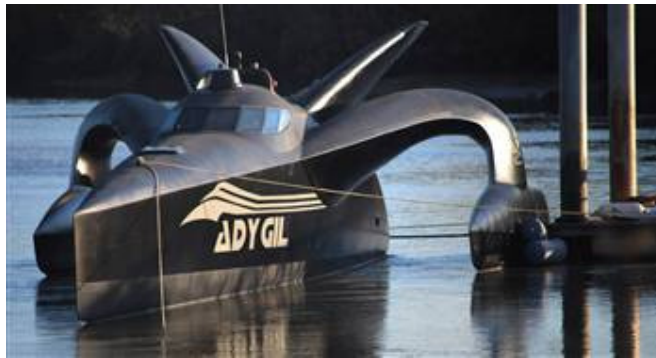
Figure 1: *Ady Gil*

The *Ady Gil* is a tri hull wave piercer (Figure 1). At the time of the incident, it was owned by *Ady Gil/ Earthrace Limited* and registered in the Port of Wellington, New Zealand. It is unknown to what standard it was built or if there were any limitations to its area of operations. The vessel was being operated as part of the Sea Shepherd Conservations Society (SSCS) fleet.

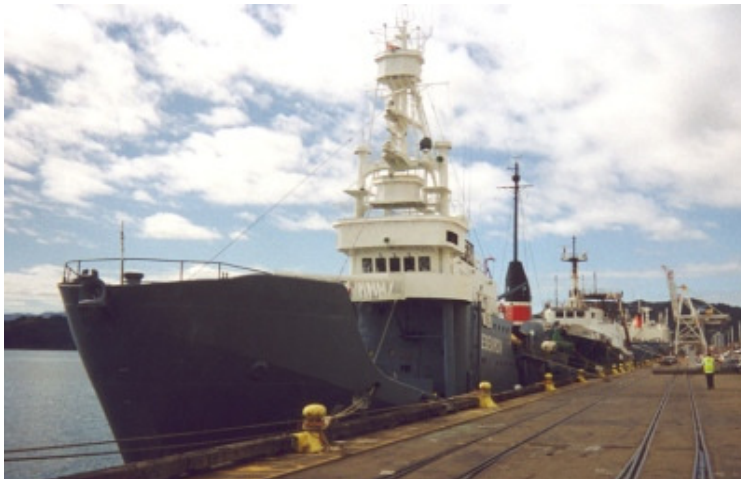
Figure 2: *Shonan Maru No. 2*

The *Shonan Maru No. 2* is a single hull whaling ship IMO7225166 (Figure 2). At the time of the incident it was owned by *Kyodo Senpaku Kaisha Ltd.* under charter to the Institute of Cetacean Research whose head office is based in Tokyo, Japan. The *Shonan Maru No. 2* is registered in Japan and classed with *Nippon Kaiji Kyokai (NKK)*.

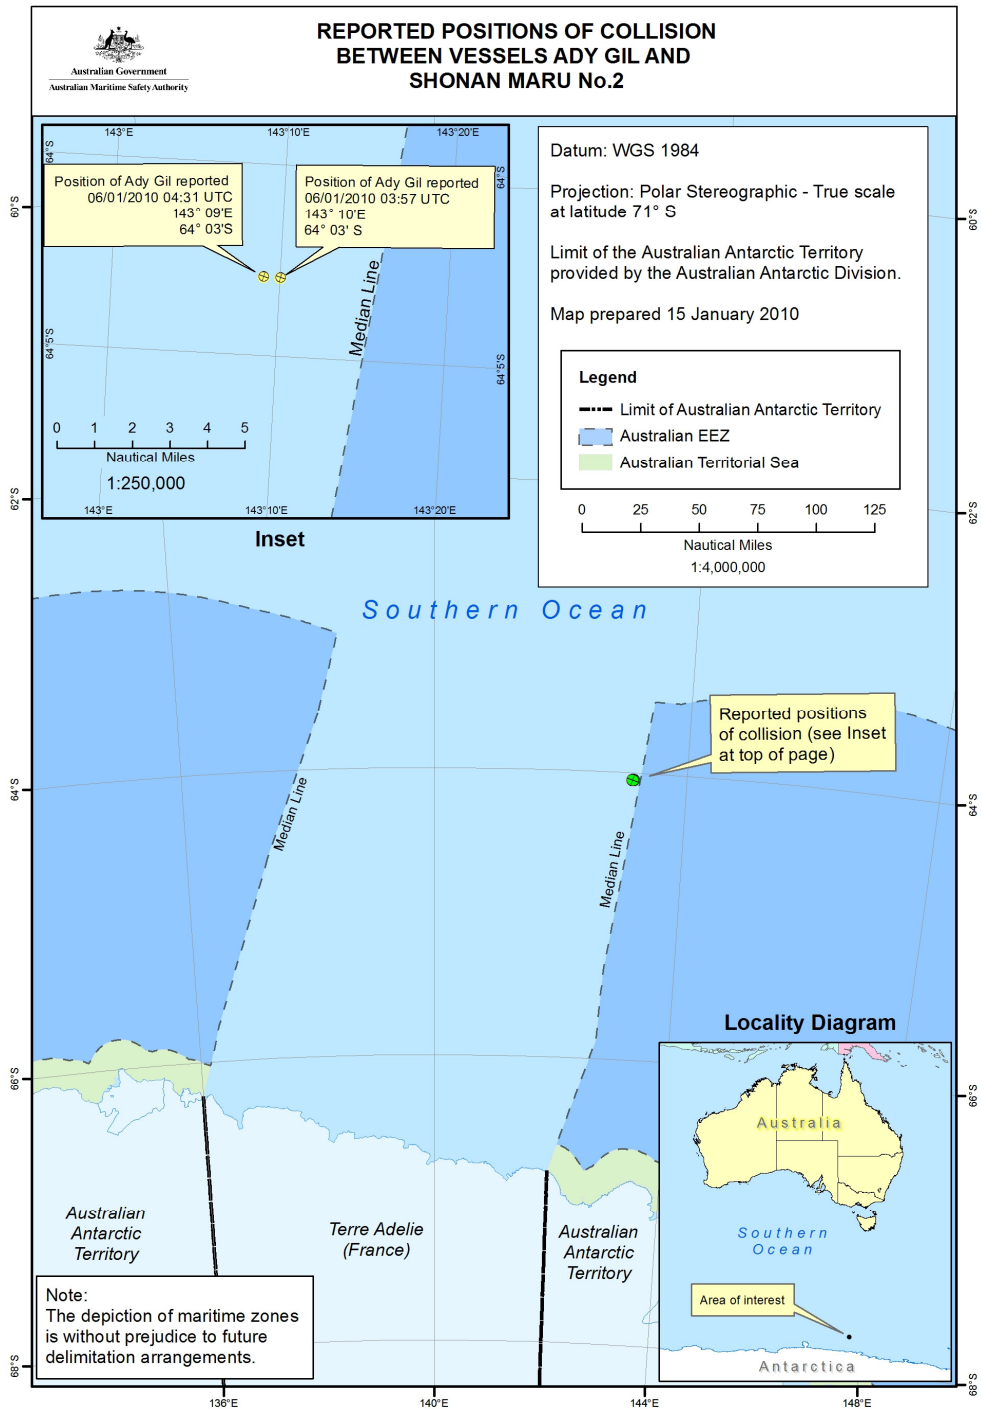
Figure 3. Reported positions of collision – 1: 4 000 000 scale.

The reported location of the collision is not in Australian waters. The location of the incident, as SSCS reported it to the RCC, is within Australia's search and rescue region but outside of Australia's territorial sea adjacent to Antarctica.
