Marine Notice 2023/04 Supersedes 2022/03

Pilot transfer arrangements

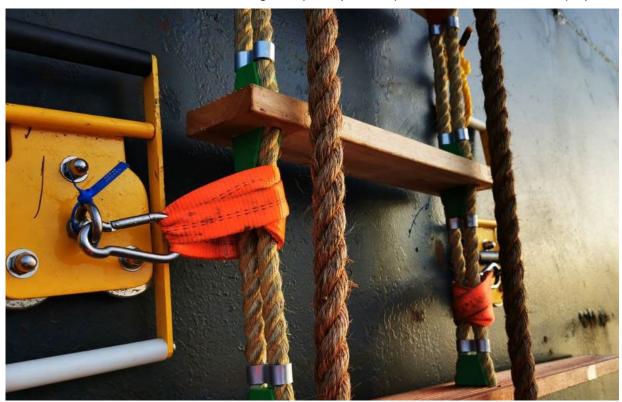
When using a combination pilot ladder arrangement, the pilot ladder and accommodation ladder are required to be secured to the ship's side. A common means of securing both the pilot ladder and accommodation ladders is with magnetic pads (refer to photo 1 below as an example).

Photo 1: Example of securing both the pilot ladder and accommodation ladders with magnetic pads (Reproduced with permission from Fremantle Ports).

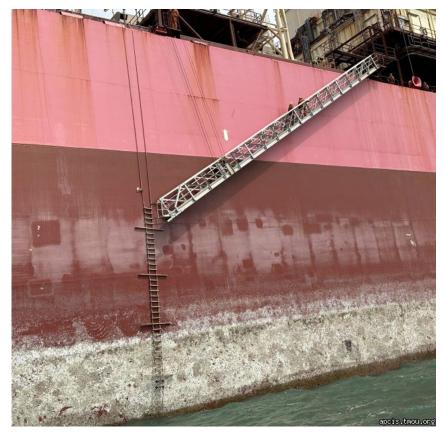
One common issue found is that the pilot ladder does not extend the required 2.0 m past the accommodation platform when a combination arrangement is used. Photo 2 illustrates an example of a pilot ladder not extending the required height past the platform.

Photo 2: Example of non-compliant combination pilot ladder arrangements.

As shown in photos 2 and 3 persons cannot climb the pilot ladder to a level where they can move safely onto the accommodation ladder.

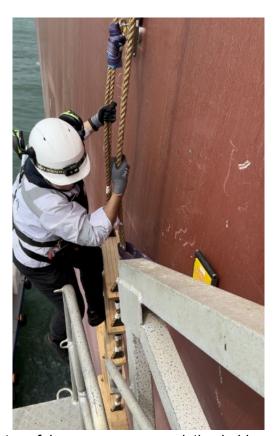
Photo 3: Person unable to safely access accommodation ladder platform from pilot ladder.

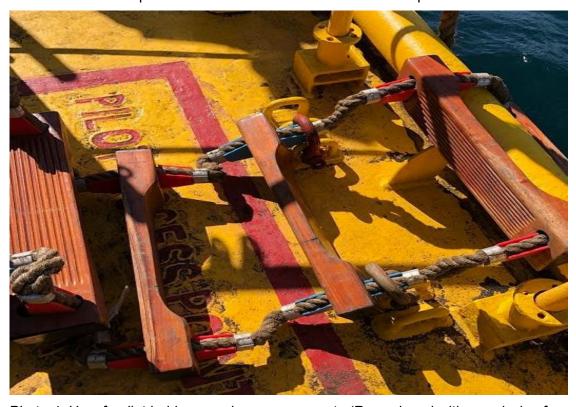
The ladder's steps, spreaders or chocks should not be used to carry the weight of the ladder as they are not designed for this and do not have sufficient strength. For this reason, shackles, bars and tongues should not be used to secure the ladder to the deck. They will damage the ladder and put weight on the parts which are not designed to carry the weight.

Photo 4 shows an example of an unsafe use of shackles to secure pilot ladders.

Photo 4: Unsafe pilot ladder securing arrangements (Reproduced with permission from Fremantle Ports).

It is common industry practice to use a rope stopper usually in the form of a rolling hitch knot between the pilot ladder sides ropes and the approved strong point on the main deck. This will transfer the weight of the ladder arrangement directly onto the designated strong point and will not damage the ladder.

It is suggested that two strong (at least 2 x 24 kN) manila ropes be used to secure the pilot ladder. Photo 6 illustrates a method of tying a rolling hitch knot.

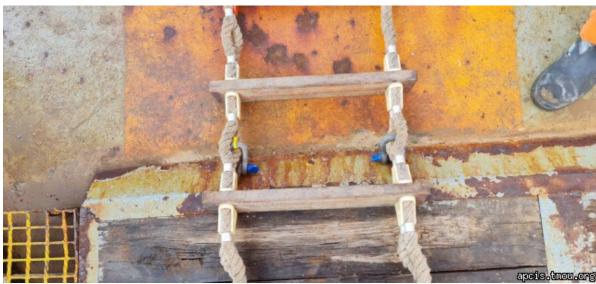
Photo 5: Unsafe pilot ladder securing arrangements.

Photos 5 shows the pilot ladder being secured to the strong point by using a shackle passed through the pilot ladder side ropes. This puts increased load on the single part of the side rope and the chock securing arrangements.

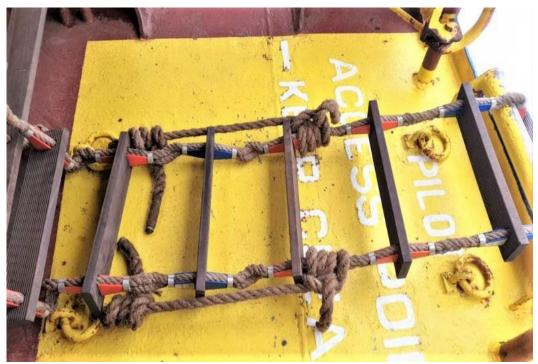
Photo 7 provides an example of rolling hitch knots being used to secure pilot ladders to approved main deck strong points.

Photo 7: Rolling hitch knots being used to secure pilot ladders to approved main deck strong points (Reproduced with permission from Fremantle Ports).

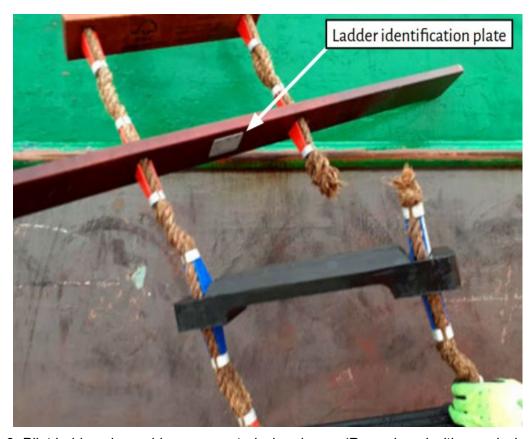
Photo 8: Pilot ladder where side ropes parted when in use (Reproduced with permission of the MAIB).

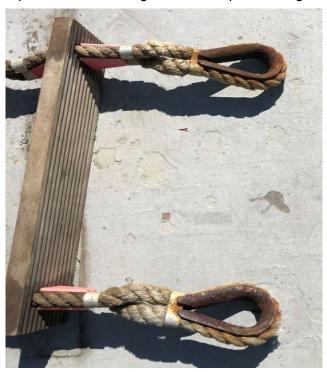
Common areas of defects can be the thimble ends of the pilot ladder. Corroded end point thimbles as illustrated in photo 9, can damage the side ropes leading to failure.

Photo 9: Example of corroded end point thimbles (Reproduced with permission from Fremantle Ports).

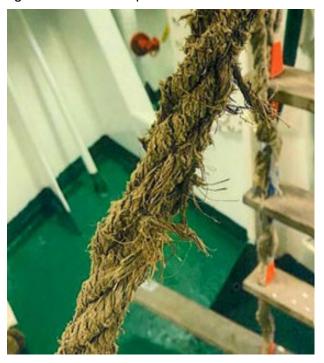
Another common area is the frayed or damaged side ropes as illustrated in photo 10. These should be detected during routine visual inspections.

Photo 10: Frayed side rope.

If side ropes are frayed, or in any way degraded the ladder should not be used.

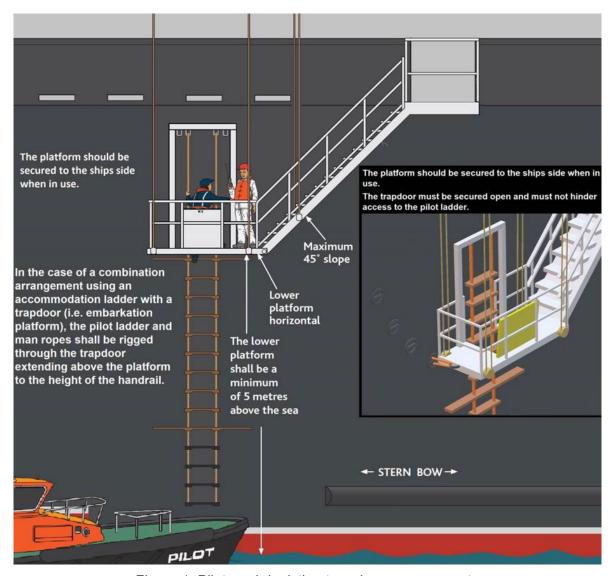
There has been an increase in ships fitted with trapdoor arrangements. The additional requirement for their use is "the pilot ladder and man ropes shall be rigged through the trapdoor extending above the platform to the height of the handrail".

Figure 1: Pilot card depicting trap door arrangements.

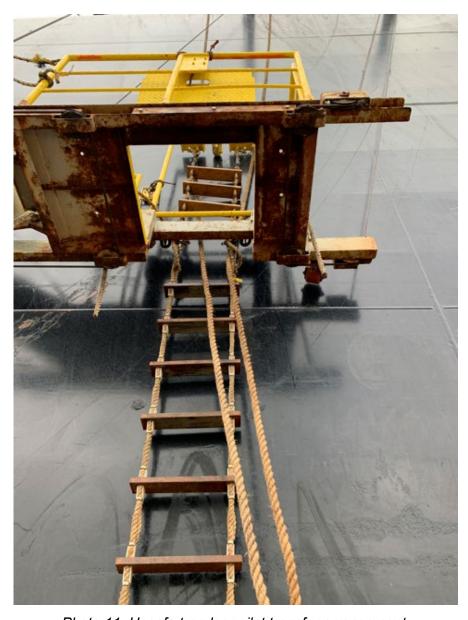
If the pilot ladder and man ropes are not rigged through the trapdoor this creates an unsafe arrangement for persons as illustrated in photo 11

Photo 11: Unsafe trapdoor pilot transfer arrangement.

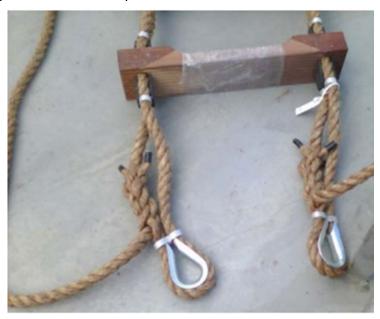
During recent PSC inspections AMSA surveyors have noted pilot ladders which have been constructed with splices in the side ropes.

Photo 12: Example of non-compliant pilot ladder with splices in side ropes.

Pilot ladders constructed like this are considered non-compliant by AMSA. Ship operators and masters are recommended to check their pilot ladders for splices in the side ropes. It should be noted by operators coming to Australian ports that the availability of compliant pilot ladders is limited in Australia. To prevent avoidable delays operators are recommended to have spare compliant pilot transfer arrangements onboard.
