Phase 8 - Focussed Inspection Campaign on Lifeboats

Summary

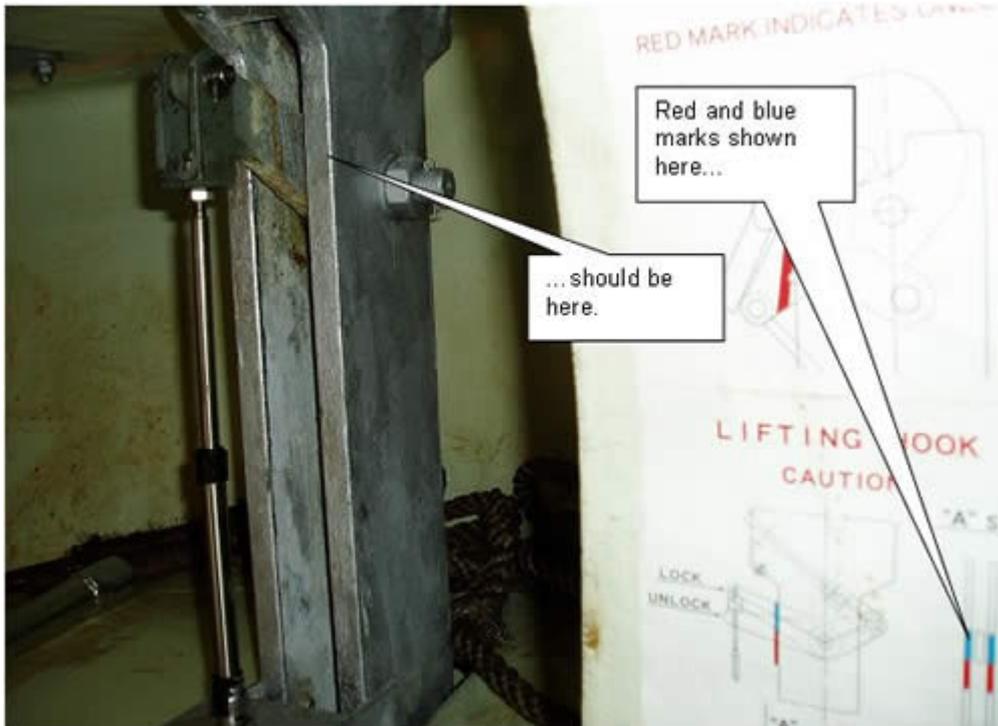
1. Example where crew had painted over the red and blue “locked/unlocked” marks on the release mechanism.

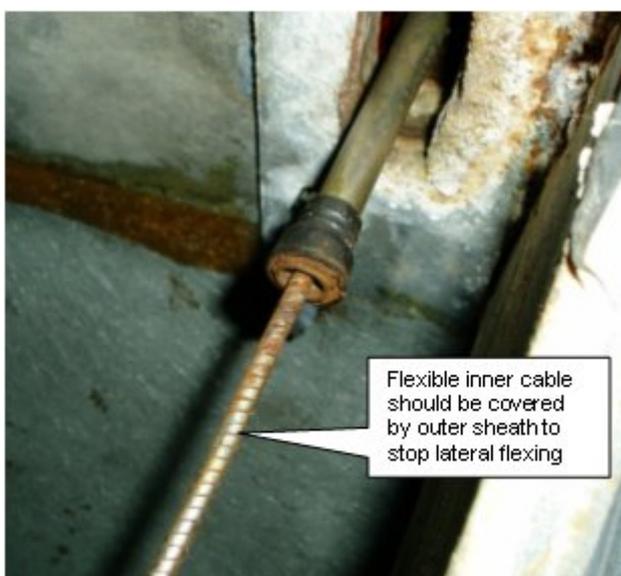
2. Morse Cable corroded and outer sheath detached leaving flexible core of cable holding mechanism in place.

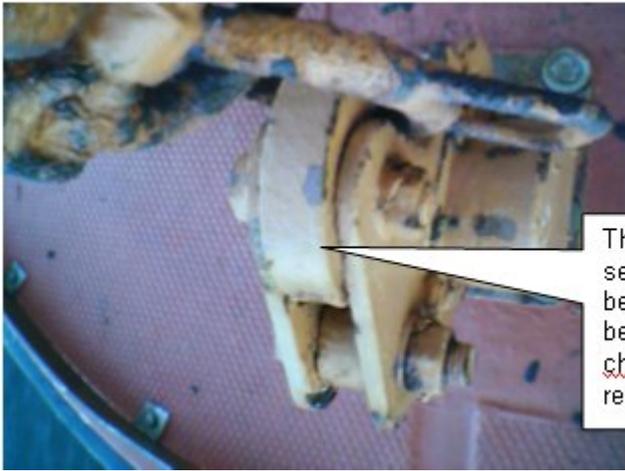
3. Release mechanism (on falls and painter) seized and morse cable corroded

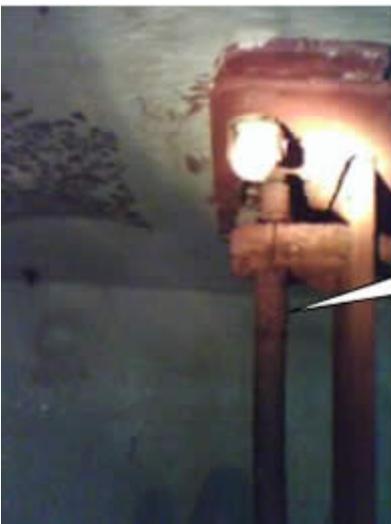
Painter release on boat seized – other end tied to ship

Morse cable connection through boat deck to release hook; sea water enters through deck and into cable corroding sheathing and seizing cable
