Marine Notice 04/2018

## High Pressure Fire Fighting Systems – Design safeguards against personal injury

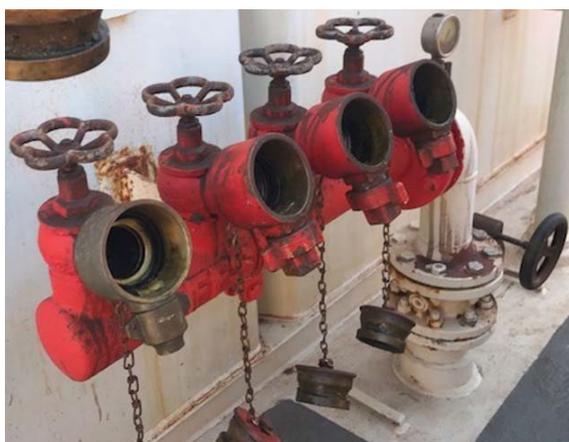
**Note:** The hydrant in question is closest to the camera.

The seafarer was attempting to remove the brass blanking cap from a hydrant valve on a manifold of four valves fitted in parallel. The other three valves had been satisfactorily checked 10 minutes earlier.

The seafarer could not release the locking pawl by hand and, assuming that it was seized, utilised multigrips to free it. The line was under pressure and when the 600 gram blanking cap came free it was expelled under pressure and struck the seafarer in the face causing severe facial injuries.

- Inadequate safe work procedures for working on high pressure systems;
- Incomplete closure of both the butterfly isolating valve to the manifold and the hydrant valve allowed air to pass the valve seat and become trapped under pressure in the hydrant chamber;
- Lack of 3mm pressure relief holes in the hydrant blanking cap as specified in AS 2419.2-2009;
- Use of heavy brass hydrant blanking caps rather than lightweight alternatives;
- Turning directions for opening and closing of hydrant isolating valve were non-standard and opposite to that shown on the valve control;
- Isolating valve indicator was unclear and positioned out of operator's line of sight;

AMSA notes that SOLAS does not require pressure relief holes in blanking caps. However, AMSA strongly recommends that the requirement for 3mm pressure relief holes in hydrant blanking caps, as specified in AS 2419.2-2009 – *fire hydrant installations*, be complied with.

AMSA also recommends the fitting of securing chains or wires to blanking caps as specified in AS 2419.2-2009 – *fire hydrant installations*. This is designed to prevent the loss of the cap.

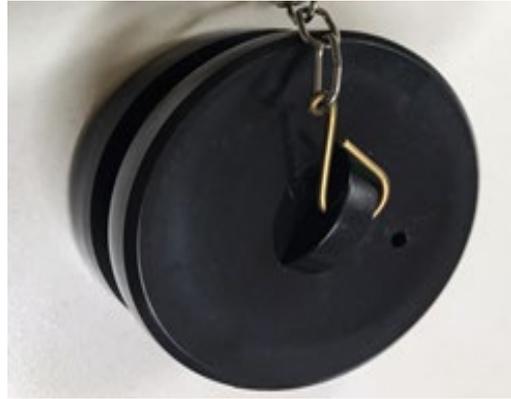
**Note:** the lightweight blanking cap shown below is fitted with a pressure relief hole and a securing chain.

Blanking caps are also available in a lightweight plastic composite material, which would significantly reduce impact forces should all other controls fail. AMSA supports the use of lightweight alternatives where appropriate.
