Shaping Shipping for People

Working over the side

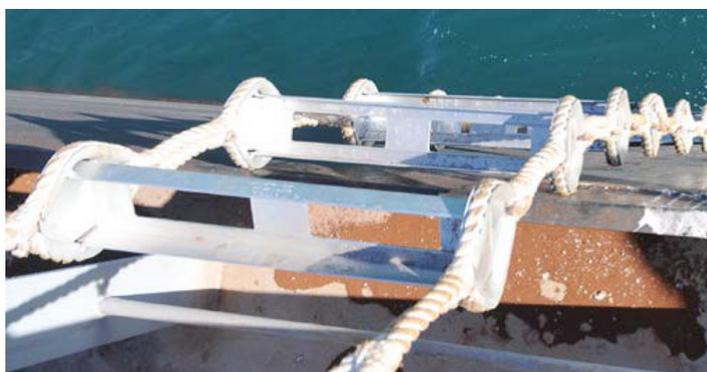
- the rope ladder was rigged upside down which meant that the ladder steps did not provide for a flat surface to stand on and comfortably hold onto
- no fall prevention measures were put in place
- no man-overboard responses were in place (such as lifebuoy with light and line positioned near the ladder).

Figure 2. Rope ladder, as rigged at the time of the accident [1].

Climbing down a vertical rope ladder in the early hours of the morning to read draught marks would have presented difficulties for anyone. While the lack of adequate control measures for working over the side contributed to this tragedy, the risks associated with conducting the activity remain high. The terminal managers subsequently put in place a revised procedure prohibiting the reading of draught marks from rope ladders and an alternate method, using a manometer, was put in place.

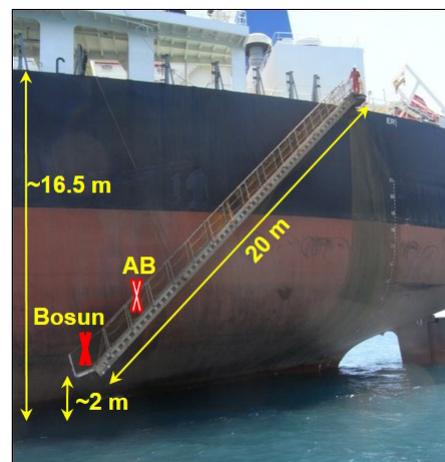
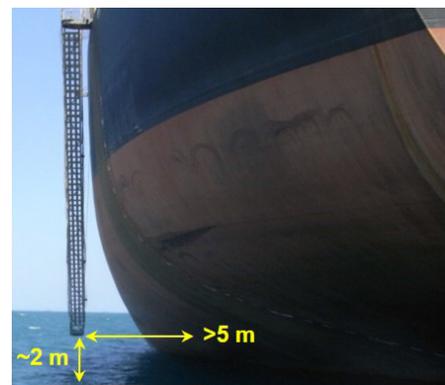
The ATSB found that the bosun, and the seaman who was with him at the time, were not wearing any flotation devices or fall prevention equipment. The bosun had seen fish below the accommodation ladder and probably saw it as a good opportunity to fish without considering the risks involved.

The ATSB investigation also identified that the ship's safety management system procedures for working over the ship's side were not effectively implemented. The ship's crew routinely did not follow all the required safety precautions when working over the side. It was also found that the crew had differing attitudes to safety during work and recreation times as the safety culture on board was not well developed.

Figure 7: The accommodation ladder as rigged at the time of the accident showing approximate positions of the bosun and able seaman [2].
