**MONTARA WELL RELEASE
TIMOR SEA**

**OPERATIONAL MONITORING
STUDY 02**

**MONITORING OF OIL
CHARACTER
FATE AND EFFECTS**

**WATER QUALITY
REPORT 02**

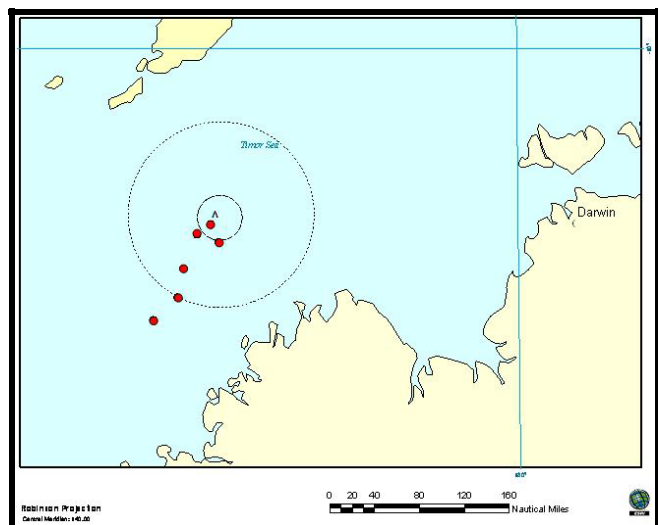
Figure 2 Study S4A 2009 Sample Locations

Analytical results are provided in Attachment C. Samples were taken to depths of up to 20m. Sampling locations are shown in Figure 2. No water samples showed the presence of TPH.

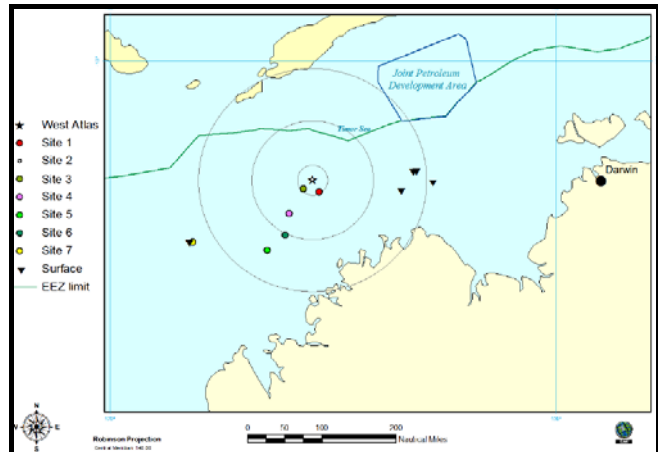
Figure 2 Study S4A March 2010 Sample Locations

2010 sampling locations are shown in Figure 3. No water samples showed the presence of hydrocarbons.

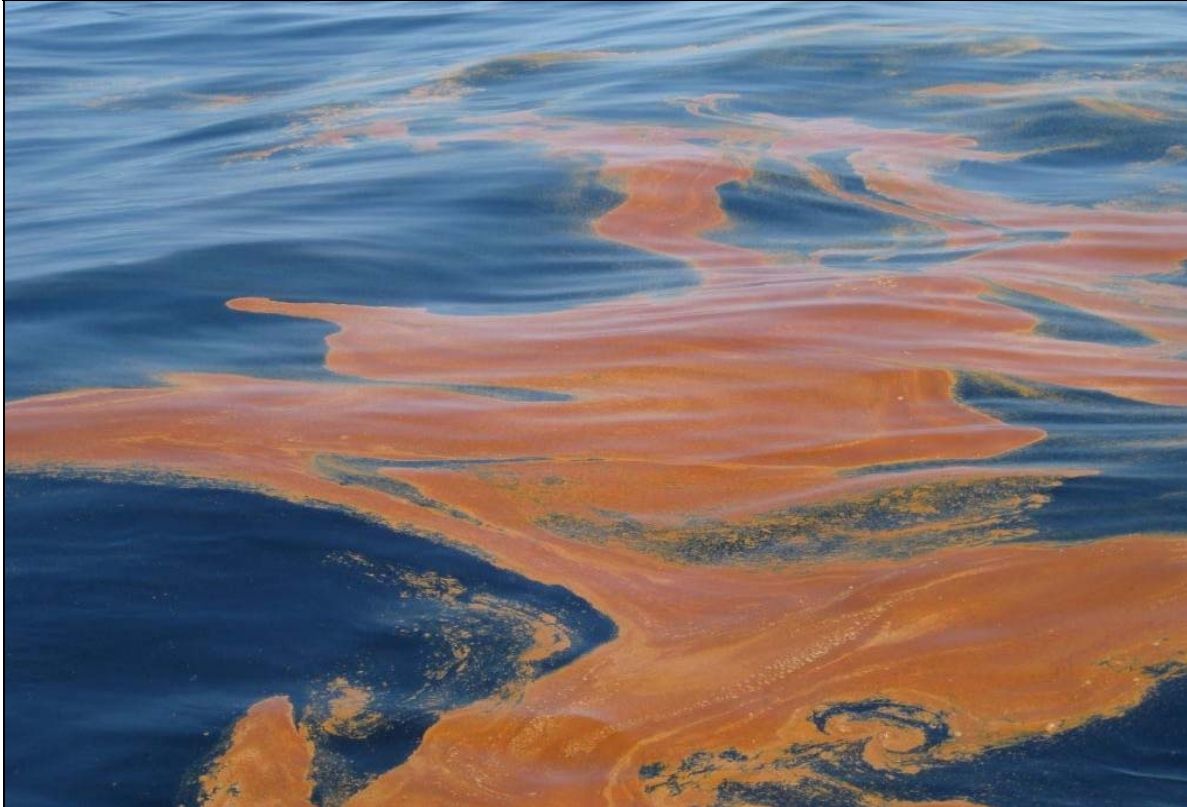
C15-C28 hydrocarbons were detected at all depths at this location. Further analysis of these samples showed no presence of BTEX or PAHs. The samples were taken below a surface slick of orange coloured oil (see A.3 in Attachment A).

A.3	Location	12° 39.9' S, 124° 35.7 E				
	Site Description	Beneath an orange oil slick. Approximately 3 nautical miles east of the West Atlas oil rig. Weather conditions were fine, hot, and still, with no wind. Photographs of this slick appear in Attachment 2. These samples were taken at approximately 08:30 on the 4 th of October.				
	Results	Depth	1 m	2 m	3 m	5 m
		Leeder ID	2009020411	2009020412	2009020413	2009020414
		TPH C6-C9	ND	ND	ND	ND
		TPH C10-C14	ND	ND	ND	ND
		TPH C15-C28	0.09	0.12	0.09	0.08
TPH C29-C36		ND	ND	ND	ND	
Total TPH	0.09	0.12	0.09	0.08

This location was within the area in which dispersant operations were undertaken and it is possible that the detected hydrocarbons were from operations completed in the previous few days. Conditions were calm and natural dispersion is unlikely.
