Navigation Safety: Using Electronic Chart Display and Information Systems

In this issue, we focus on navigation safety, in particular issues associated with the use of Electronic Chart Display and Information Systems (ECDIS).

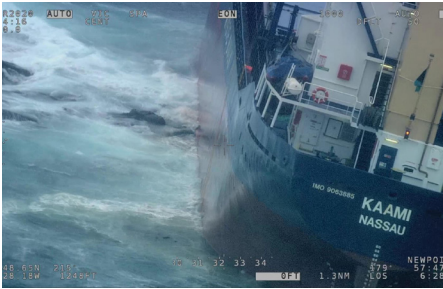
At 0141 local time on 23 March 2020, the general cargo ship Kaami ran aground on to rocks in the Little Minch on the west coast of Scotland, causing significant hull damage³.

The MV Kaami aground (MAIB)

While there were no injuries and environmental impact was minimised, the damage to Kaami's hull was extensive and the ship was declared a constructive total loss.

The investigation report identified that:

- the mandatory generic and type specific training for the ECDIS were found to be inadequate for crew to perform their functions safely.
- the on-board operation did not allow adequate opportunity for the voyage plan to be checked and verified by a second member of the bridge team.
- the safety management system did not provide adequate safeguards

for voyage planning and ECDIS use, and the ship operator's internal auditing program did not identify shortfalls in practice.

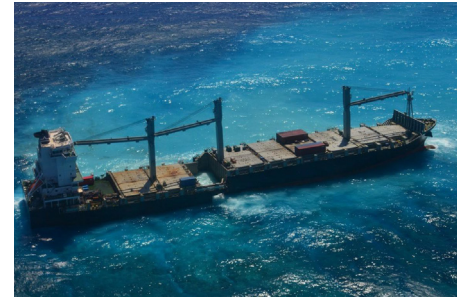
At 0055 local time on 12 July 2017, the Maltese registered container ship Kea Trader ran aground off the coast of New Caledonia⁴.

Prior to the grounding, a minor change to the voyage plan was authorised, resulting in the track passing over an isolated danger. The danger symbol appeared outside of the charted track due to zooming-in and possibly over-scaling the ECDIS display. This led the crew to incorrectly assume the track was safe.

MV Kea Trader, aground with fractured hull (Maritime Cyprus)

During the salvage attempt, a structural fault resulted in the hull fracturing in heavy seas. The ship was declared a constructive total loss.

- No independent route check was conducted, nor was the plan signed off by the master.

- No warnings or reference to the isolated danger were documented or discussed in bridge team briefings.
- The ECDIS route check function had not been enabled.
- The audible alarm was muted during the ship's voyage.

None of the watchkeepers were aware of the actual safety settings on the ECDIS, despite the completion of bridge equipment familiarisation forms. The 'caution area' messages repeatedly displayed in the subsequent navigational watches were largely overlooked by the bridge team.

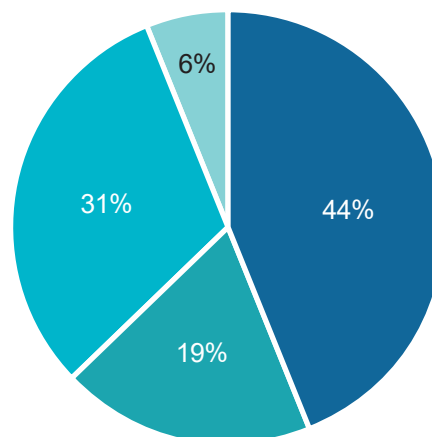
AMSA recorded 11 reported grounding incidents involving regulated Australian vessels between 2016 and 2020, that were due to navigational issues. Some of the issues identified within these incidents are shown in the chart.

6% - operating on non-approved software (ECDIS), 1

44% - Inadequate passage planning, 7

19% - Poor watchkeeping, 3

31% - Poor navigational practices, 5

Grounding incidents related to navigational issues
