***PORT STANVAC***

**OIL SPILL**

**REPORT OF THE  
INCIDENT ANALYSIS TEAM**

**Response to the oil spill at Port Stanvac  
on 28 June 1999**

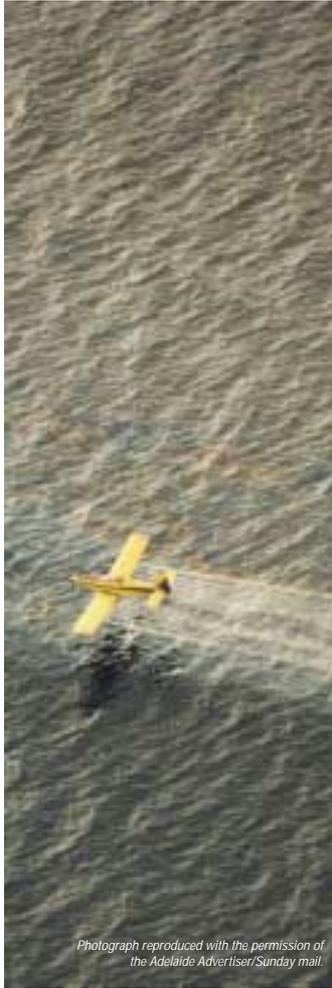
*Aerial dispersant application by Air Tractor.*

Aerial dispersant application operations commenced at 0906 hours. Initial reports received from the control helicopter indicated the dispersant application was very effective.

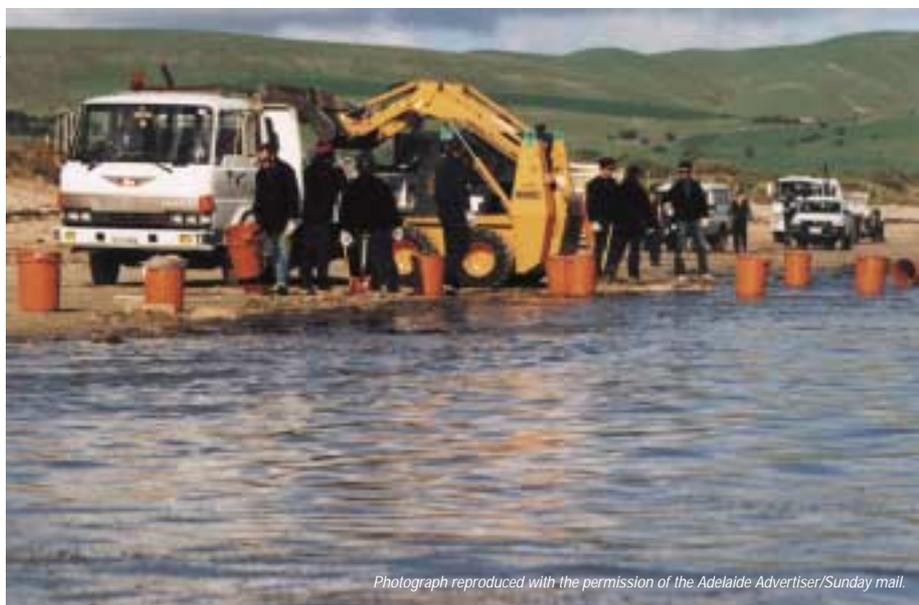
Beach clean-up operation at Sellicks Beach

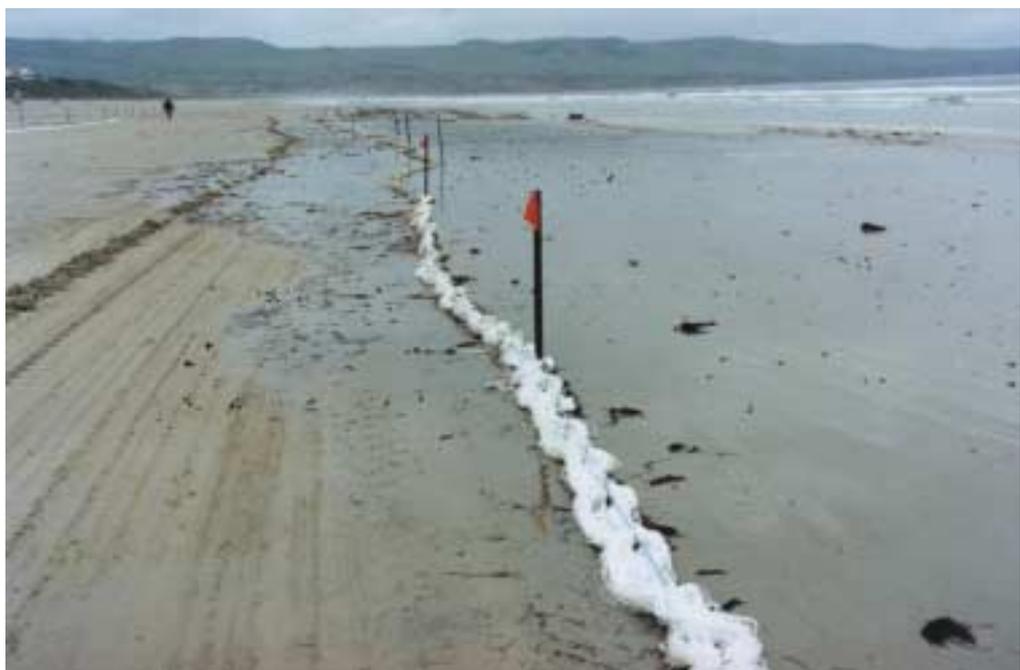
*Snares used in surf line at Sellicks Beach.*

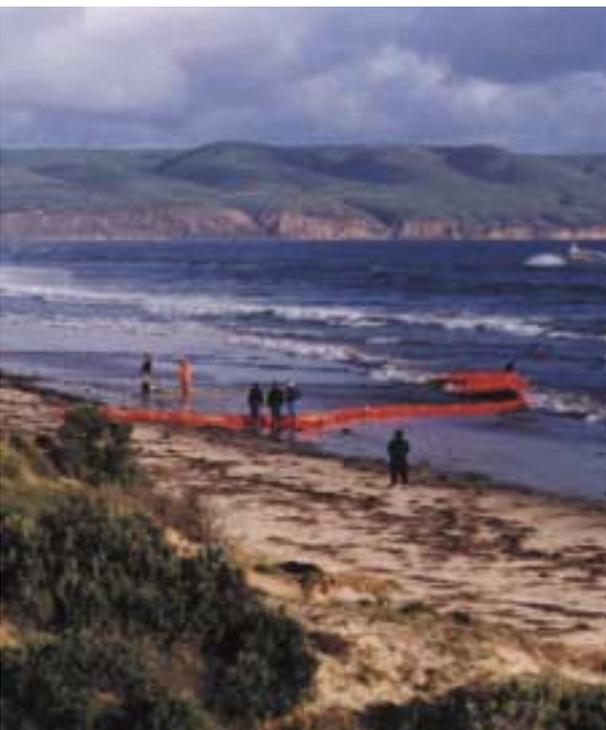
*Shoreline protection boom being deployed at Sellicks Beach*

Difficulties were experienced deploying a shoreline protection boom in rough weather conditions using a small low powered inflatable dinghy which flipped spilling its two occupants into the sea.

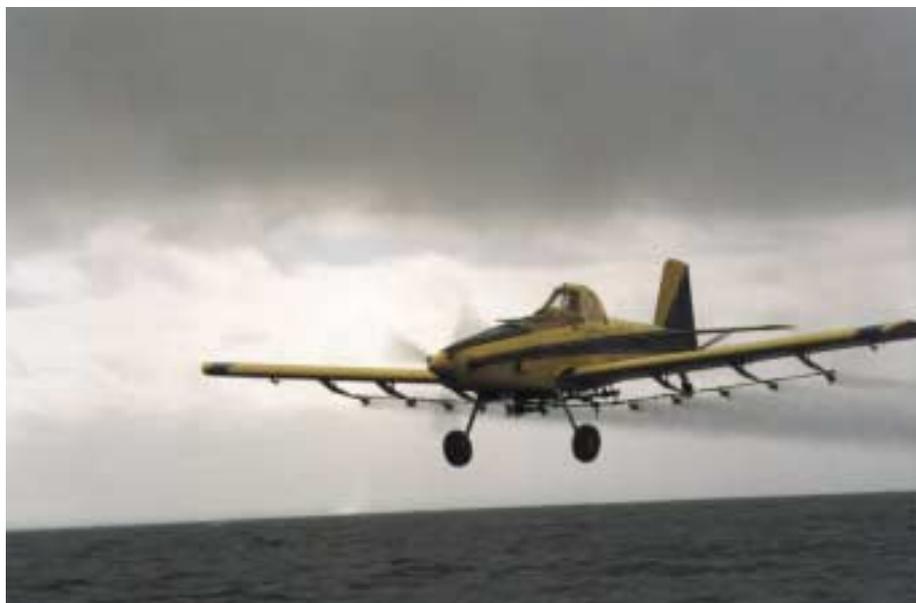
*An Air Tractor used in dispersant application operations*
