Marine Notice 13/2017

Ship accommodation ladders with unapproved secondary means of support arrangements

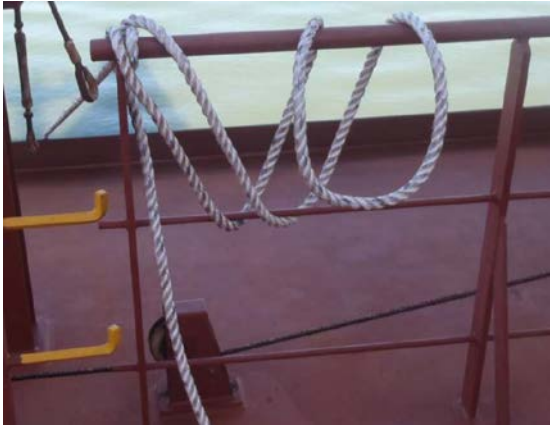
- they are connected to vessel's cranes or davits with insufficient SWL;
- they are fixed to non-load bearing parts of the accommodation ladder and vessel structure;
- the tensile strength of ropes, wires, pullies and fittings is inadequate.

Unapproved secondary means of support tied to non-loading bearing part of accommodation ladder and vessel structure

AMSA does not object, in principle, to a secondary means of support that is properly designed and fit for purpose. A risk assessment of any secondary means of support arrangements should be undertaken onboard according to the vessel's safety management system.

Procedures for the fitting, maintenance and operation of the secondary means of support arrangements should be included in safety management system procedures and crew should be inducted and trained in the use of these arrangements.

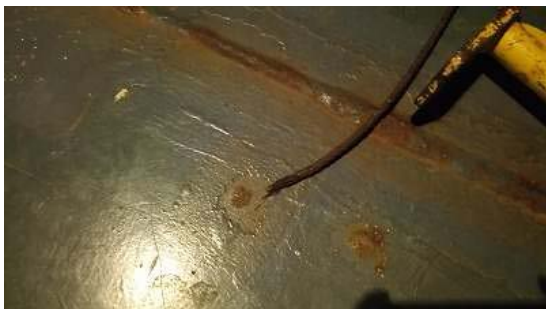
Parted wire from unapproved secondary means of support

The hoisting wire of a davit crane, which was being utilised as a secondary means of support, parted while ship's crew were lowering the accommodation ladder to allow a draught surveyor to embark. The davit crane section of parted wire, block hook, the bridle and wire ropes fell onto the accommodation ladder.

In all the above examples the secondary means of support were inadequate to support the weight of the accommodation ladder and therefore only introduced hazards while not providing an additional safety measure.

AMSA does not require the fitting of secondary means of support to accommodation ladders and encourages vessel owners, operators and masters to seek advice from their Administration prior to fitting such arrangements.
