Australian Maritime Safety Authority

# *YM Efficiency* salvage operation

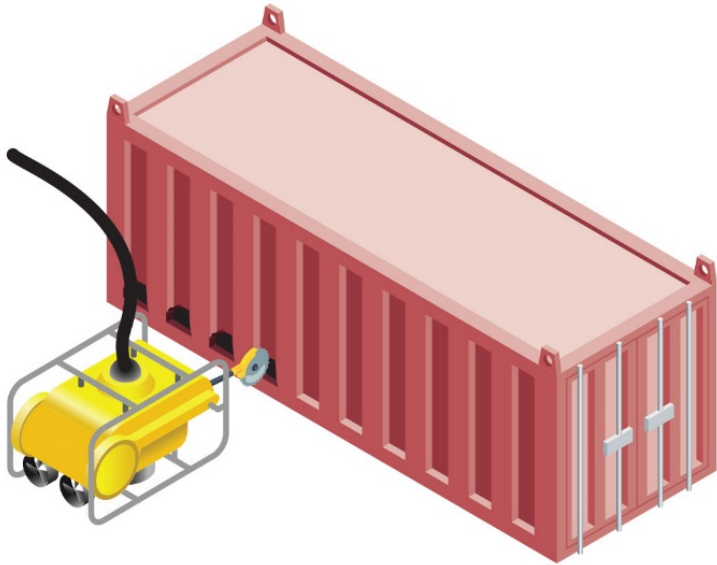
1

ROUV guides hydraulic saw to cut drainage holes in containers

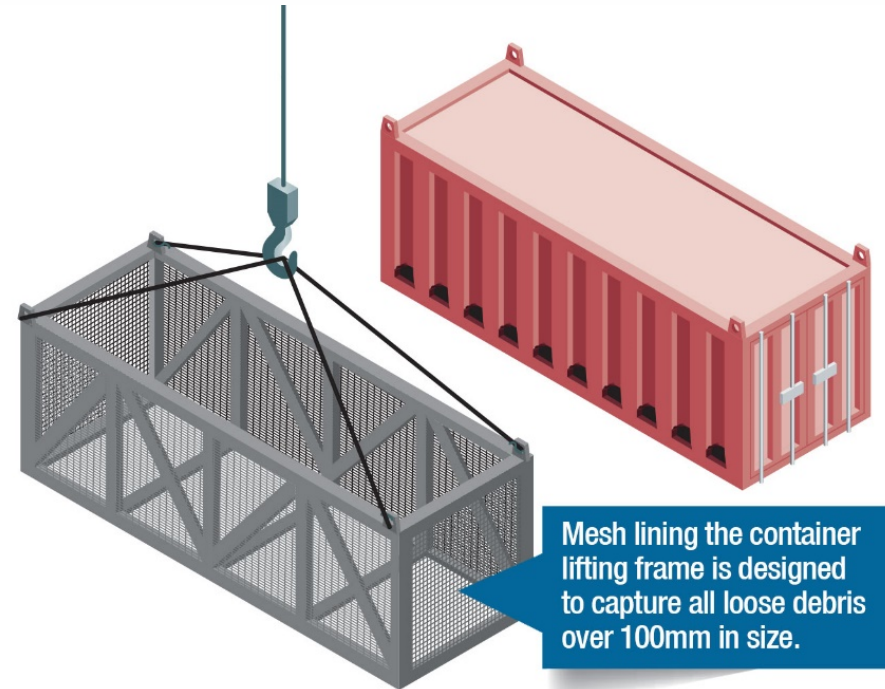
2

A specially constructed metal frame connected to the main crane is lowered next to a container.

Mesh lining the container lifting frame is designed to capture all loose debris over 100mm in size.

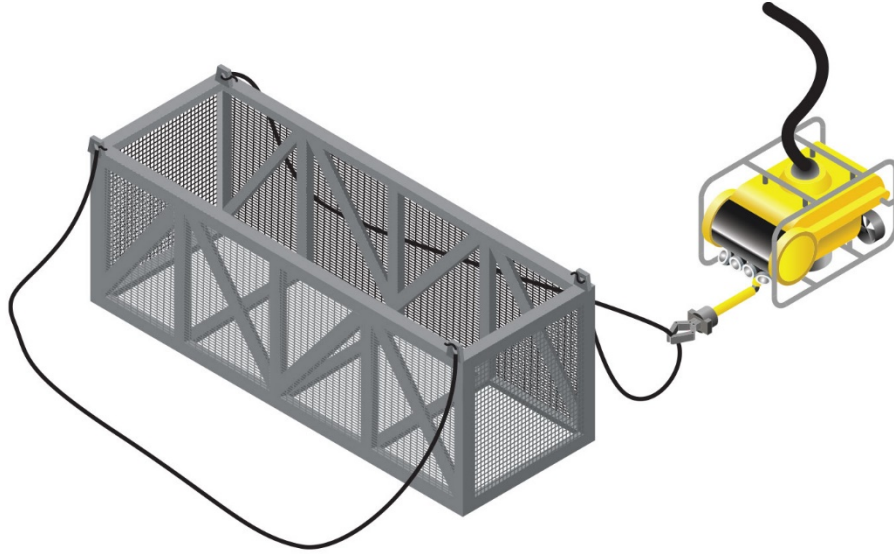
3

ROUV aids disconnection of frame rigging and creates clearance by draping it away from the frame. Crane is raised to the surface.

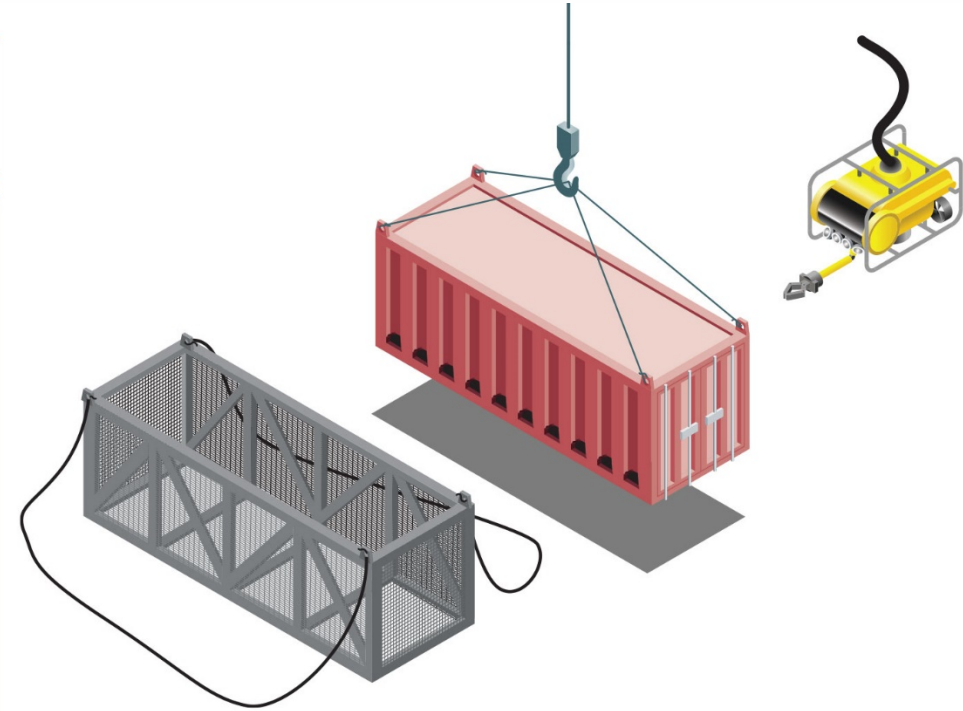
4

Container lifted from seabed by crane, while ROUV monitors integrity and exposed debris.

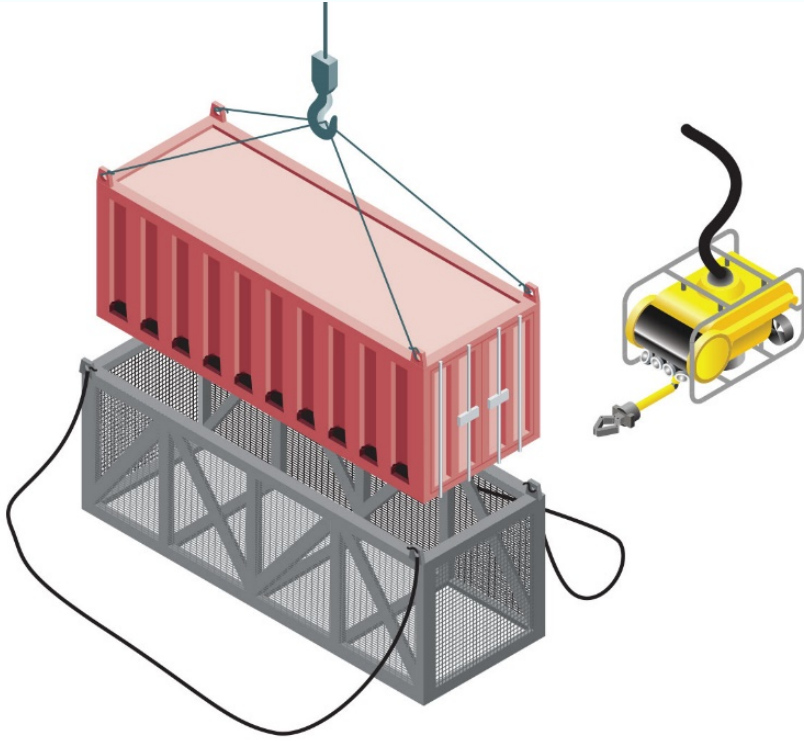
5

Crane positions and lowers container into frame, ROUV monitors and reports on position.

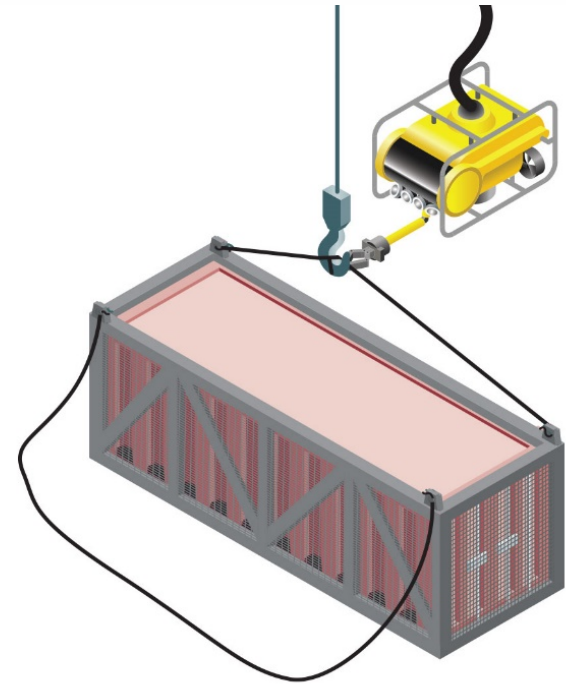
6

Rigging is lowered for connection to metal frame with container.

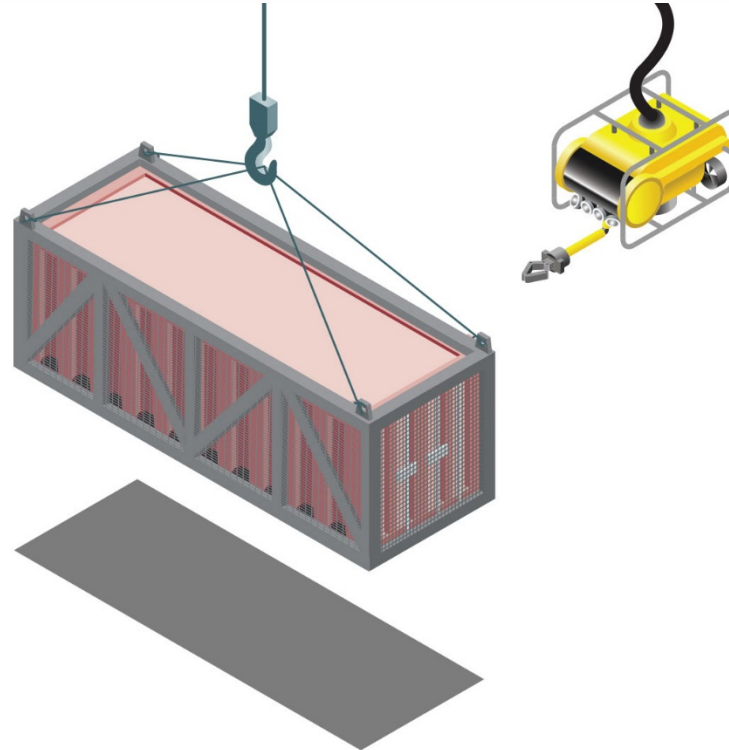
7

Rigging is pulled taut. ROUV monitors ascent to surface and reports on progress and snagging incidents.

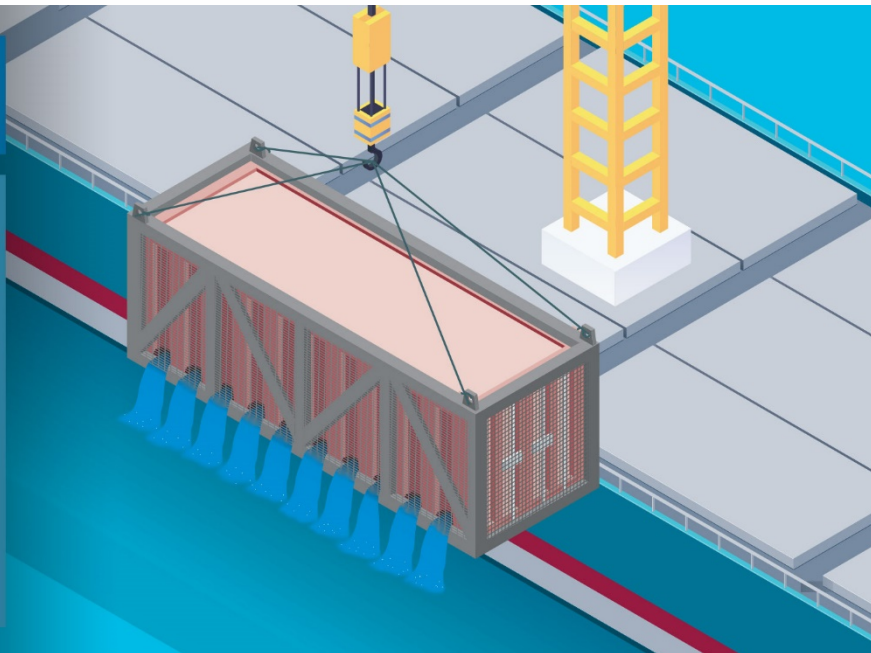
8

Frame and container lifted out of splash zone and held in position while water drains from egress holes.

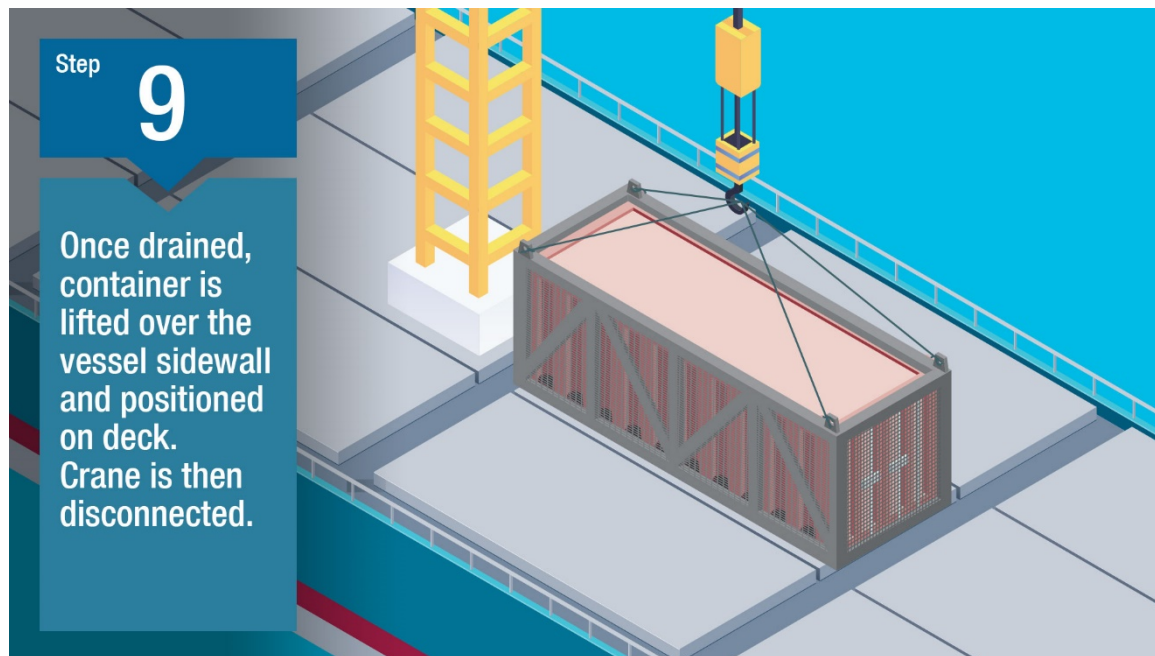
9

Once drained, container is lifted over the vessel sidewall and positioned on deck. Crane is then disconnected.
