Shaping Shipping for People

Electrical safety – an evaluation of electrical hazards

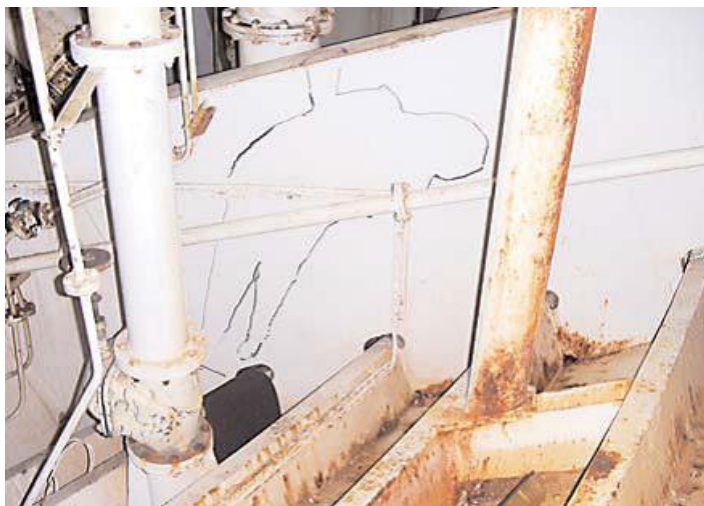
Figure 2: Location of the electrician (source: ATSB)

In May 2005, an electrician on board a bulk carrier received an electric shock which caused him to fall between a deep frame and a parallel pipe (Figure 2). He consequently died from a heart attack believed to have been caused by the electric shock [1].

The light fitting the electrician was working on was still energised. It is possible that a qualified and experienced electrician may not have seen the need to complete an electrical work permit for a 'simple' task like repairing a light fitting. However, the electrician should have isolated and tagged the power supply prior to commencing the work.

Isolation and tagging of electrical power supply are critical tasks that should be undertaken prior to commencing work

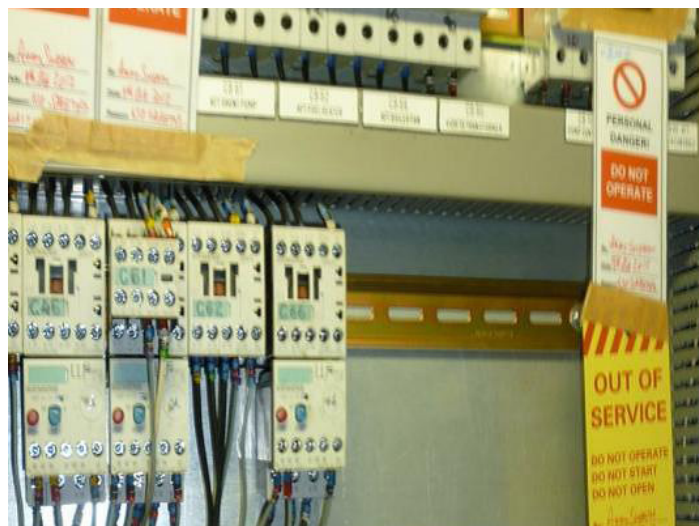
Figure 3: Safety tags on the circuit breakers (source: Transport Malta)

The engine room rating assumed that the system was isolated and safe to work on, so he started to disconnect the terminals. However, the system was not completely isolated and remained energised. The restricted working space meant that he had to kneel or sit to carry out the work. This provided a conduction pathway to complete an electrical circuit through his body, eliminating the protection provided by his insulated safety boots. As a result, he suffered an electric shock, which resulted in serious burns to three of his fingers.

The safety investigation concluded that poor isolation procedures, complexity of the schematic drawings and lack of familiarity with the system resulted in the engine room rating accepting risks that he did not fully understand.

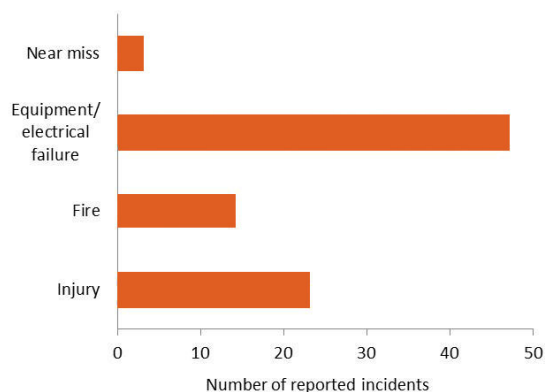
Figure 5: Primary outcomes of electrical related incidents reported, 2011-15 (source: AMSA)

Between 2011 and 2015, a total of 87 electrical related incidents were reported to AMSA. A breakdown of the outcomes from these incidents, categorised into injuries (23), fires (14), equipment/electrical failures (47) and near misses (3), is shown in Figure 5.

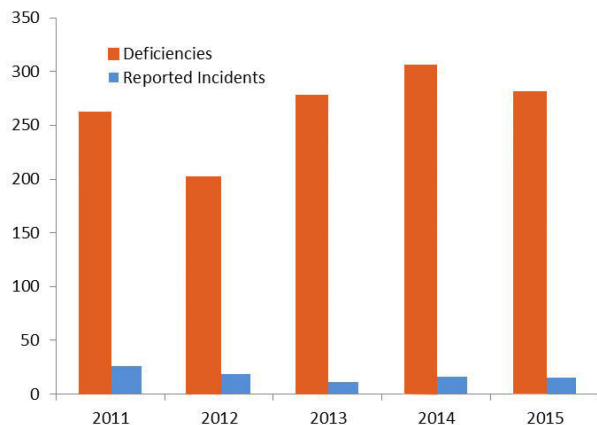
Figure 6: Electrical related PSC/FSC deficiencies and reported incident data, 2011-2015 (source: AMSA)

A comparative analysis of electrical related PSC/FSC deficiencies and reported incident data collected by AMSA during the period 2011 to 2015 is shown in Figure 6. In this period, there were a total of 1325 electrical related deficiencies issued by AMSA.

The PSC/FSC data displayed in Figure 6 possibly highlights a level of underreporting of electrical related deficiencies. Interestingly, a more detailed analysis of PSC/FSC data shows that most of these deficiencies point to hazards such as; low insulation (50%), earth faults (34%), unsafe wiring (11%), protection/isolation issues (3%) and power supply problems (2%).

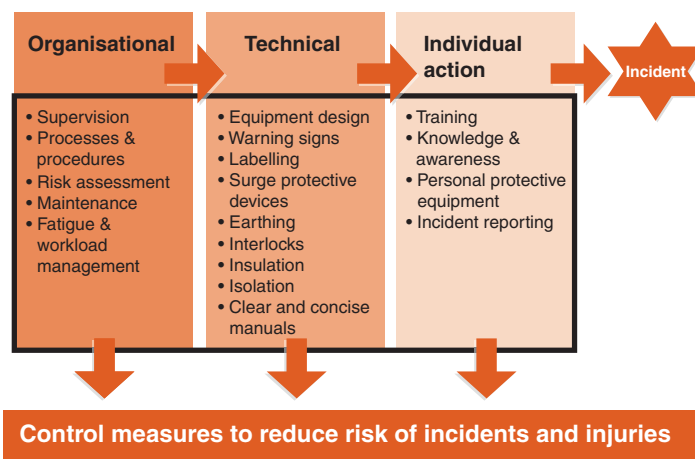
Figure 8: Defences in depth [3]

Figure 8 provides an overview of control measures that should be adopted at the organisational, technical and individual levels to ensure that the right level of 'defences' are in place to mitigate and manage the risk of electrical hazards.

These control measures at the organisational level (Figure 8) should include:

- ensuring appropriate supervision is provided;
- putting in place safe operating processes and procedures;
- carrying out risk assessments for all electrical work;
- adequate maintenance, including inspection and testing; and
- ensuring that fatigue and workload is managed appropriately.

At the technical level (Figure 8), control measures should include:

- equipment design (ensuring safe design);
- appropriate warning signs are in place including proper labelling for tag/lockouts;
- appropriate use of surge protective devices;
- ensuring electrical systems are properly isolated when required;
- carrying out regular insulation testing; and
- ensuring there are clear and concise manuals for use of electrical equipment.

At the individual level (Figure 8), control measures should include:

- appropriate training, knowledge and awareness of electrical hazards;
- appropriate use of Personal Protective Equipment (PPE); and
- reporting of electrical safety related incidents and near misses.

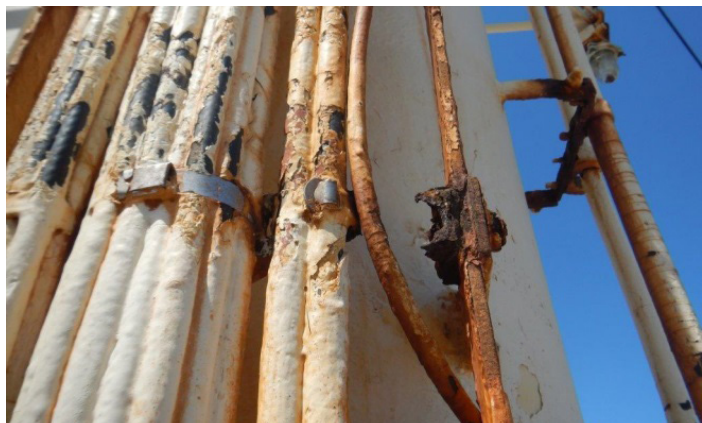
Figure 9: Wasted cable trays on main navigation mast (source: AMSA)
