This issue focuses on safe access to vessels, including:

Safe vessel access

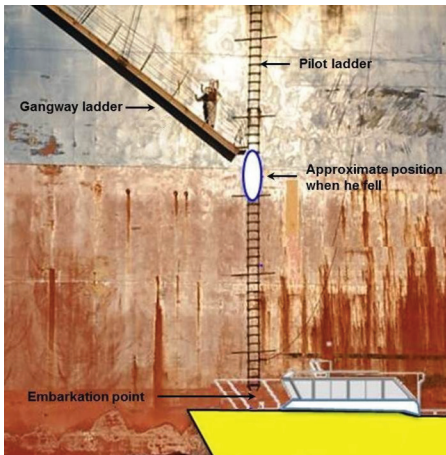
A person commenced climbing the pilot ladder while the crew were still adjusting its length. The person fell seven metres onto the foredeck of the pilot launch and died.

While the investigation found that the pilot ladder was correctly rigged, it was suspected that the deceased person was inexperienced with using pilot ladders, and may have become exhausted before reaching the top-causing him to lose his grip and fall. The vessel's safety management system provided no guidance for ensuring safe access or consideration of the person's level of experience in boarding via this method.

Case study one - A diagram of the fall from the pilot ladder

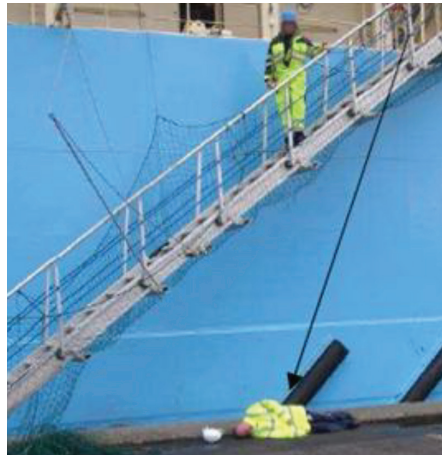
Two crew members entered the gangway to free the wire and while doing so, the handrail to the shore-side handrail suddenly fell. One of the crew lost his balance falling off the gangway to the pier five metres below—fracturing his thighbone and kneecap. He was not wearing a safety harness and fall arrest system device.

According to the accident report, the vessel departing earlier than planned resulted in rushed crew members feeling stressed and in a hurry to complete the work. The report also indicated that the crew normally employed a safety harness and fall arrest device while working on the gangway, but did not do so on this occasion due to work stress and the jammed lifting wire.

This incident was a result of known problems with the gangway not being fixed. Issues with the lifting wire occurred frequently and were also common in other offshore vessels within the company's fleet. These problems remaining unaddressed are a sign of a systemic failure in implementing the safety management system across the fleet.

Case study 2 - Re-enactment of fall

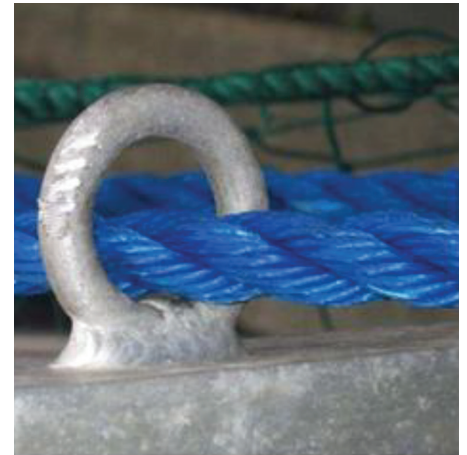
An offshore marine vessel departing port was stowing the gangway when the lifting wire became stuck on the handrail.

Stanchion eye where the lifting wire got caught

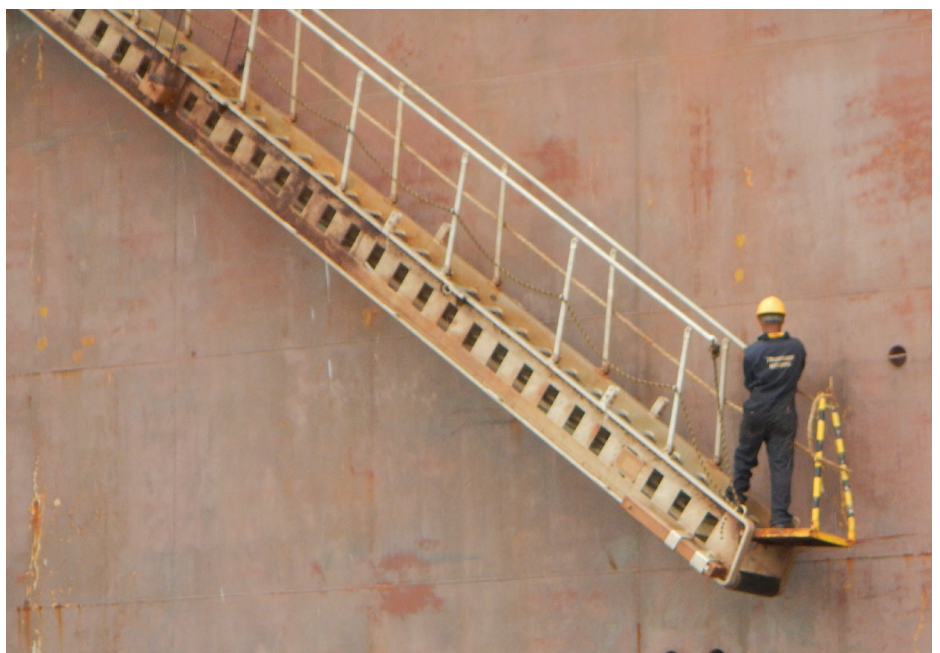
Figure 2:
Incidents due to defects between Jan 2017–May 2019

During the same period, 62 safe access accidents and incidents were reported with 38 due to defects.

These statistics indicate safe access is a significant safety issue. Defects in the equipment, particularly gangways and accommodation ladders being the major cause.

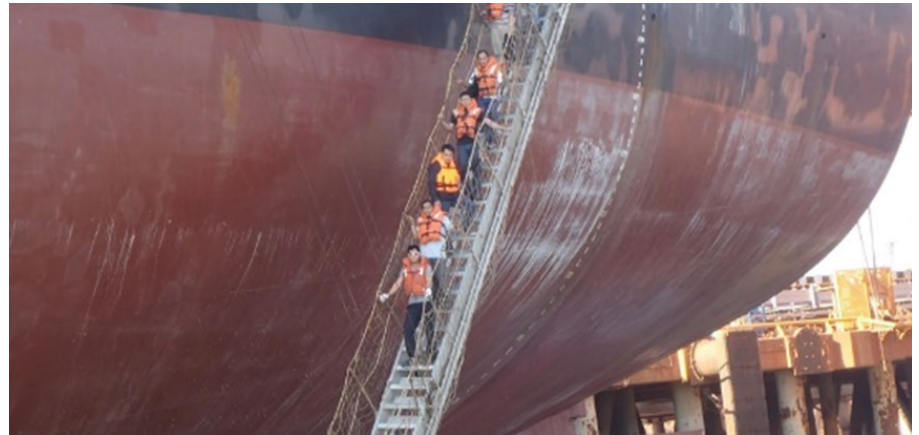
There is a high risk of a person losing their footing and causing others to fall with them.

Unsafely rigged accommodation ladder. Source: AMSA Marine notice 13/2014 presentation

- Gangways should not be used at an angle of inclination greater than 30 degrees from the horizontal.
- Ship accommodation ladders should not be used at angles greater than 55 degrees from the horizontal, unless designed and constructed for use at angles greater than these, and marked as such.
- Adequate lighting, lifebuoys and a mounted safety net sufficient to prevent falls must also be provided.
- Accommodation ladders and gangways shall be positioned well forward of propeller and avoid the lower part of the ladder and gangway overhanging off steep ship sides.
- The picture below shows a poorly selected access method and an unsafe rigging accommodation ladder.
- The ladder is rigged at more than 55 degrees from the horizontal.
- It is suspended over the sea.
- There are more people on the ladder than the load rating of the gangway.

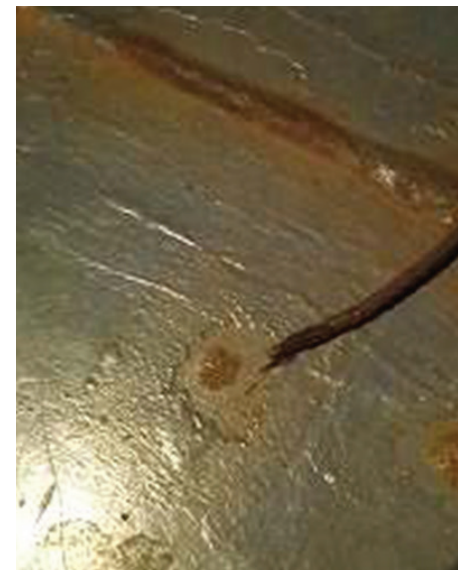
A corroded wire rope on an accommodation ladder, having parted. Source: AMSA Marine notice 13/2014 presentation

- regularly inspecting the underside of gangways and accommodation ladders
- careful attention given to the hoist wire, including the dates for renewal of wires used to support vessel access, as per SOLAS II-1/3-9)
- check the accommodation ladder and gangway each time after they are rigged.

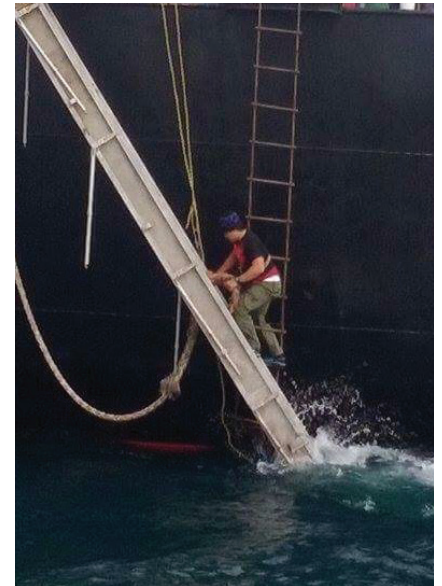
The picture (right) shows a crew member securing a fallen defective accommodation ladder via a pilot ladder without wearing appropriate personal protective equipment, such as a lifejacket or fall-arrest device. The cargo vessel is underway and the risk of the crew member being injured or falling in the water close to a propeller are high.

The consequences when vessel access systems fail are high and potentially fatal. It is important to conduct a risk assessment of the rigging, adjusting and derigging of access equipment, including the selection of appropriate equipment and secondary means of support – refer to Marine Notice 13/2017. These mitigation measures
