Phase 8 - Focussed Inspection Campaign on Lifeboats

Summary

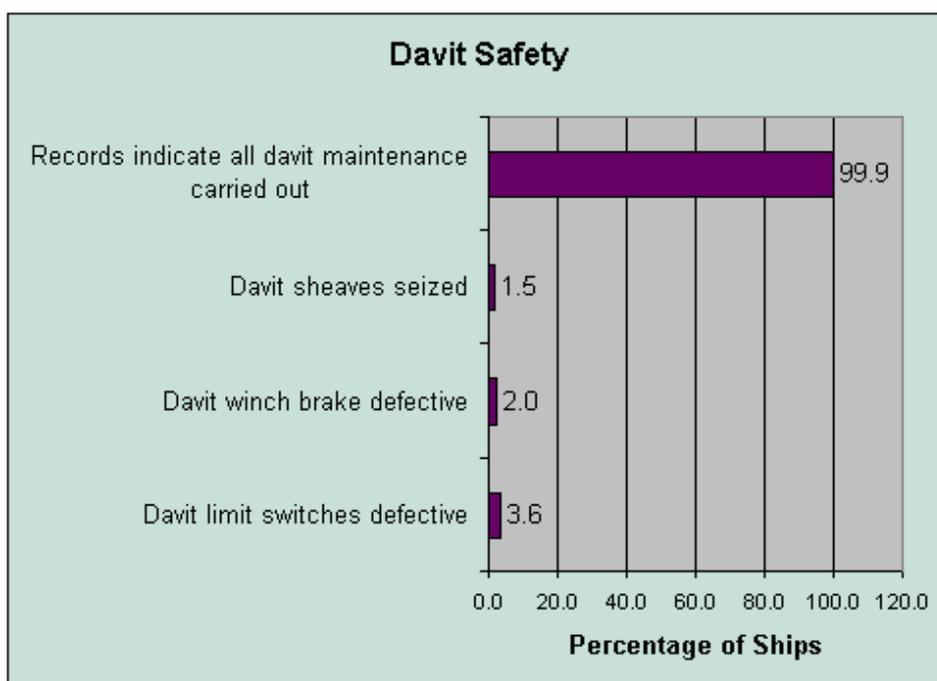
Questions were asked and tests carried out to assess the condition of lifeboat davits. Although in 99.85% of cases records indicated that the davits were maintained and in good condition as per the ship ISM system requirements, a significant number were still found to have significant defects. 22 ships had defective davit limit switches while 12 ships had defective davit winch brakes – such defects have caused serious accidents in the past.

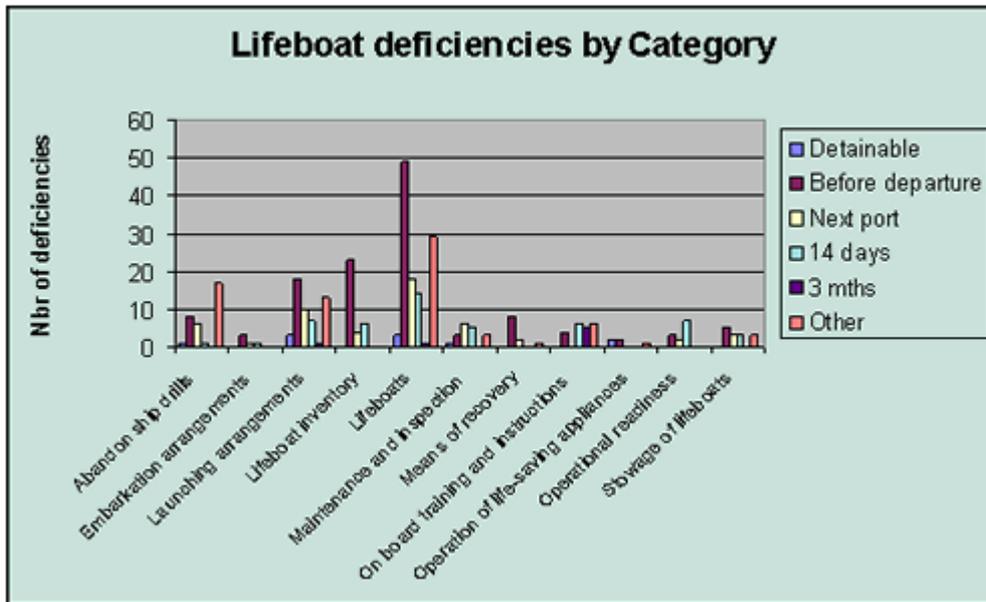
Particular attention was paid to the attachments of the lifeboat lifting hooks to the boat structure. In 8 cases (1.2% of ships where this was applicable) these attachments were found to be in unsatisfactory condition; generally due to corrosion. In total, 147 deficiencies were found with lifeboats and their inventories including cracks in the hull, defects with seating arrangements, propulsion defects, equipment broken or missing and problems with lifeboat fall releases where fitted. Detainable deficiencies were found with lifeboat releases (3), launching arrangements (3), operational issues (3) and maintenance (1). The following graph shows the deficiencies found by category and action taken.
